Wetland Waters of the U.S. Study Honolulu High-Capacity Transit Corridor Project

July 10, 2009

Prepared for:
City and County of Honolulu

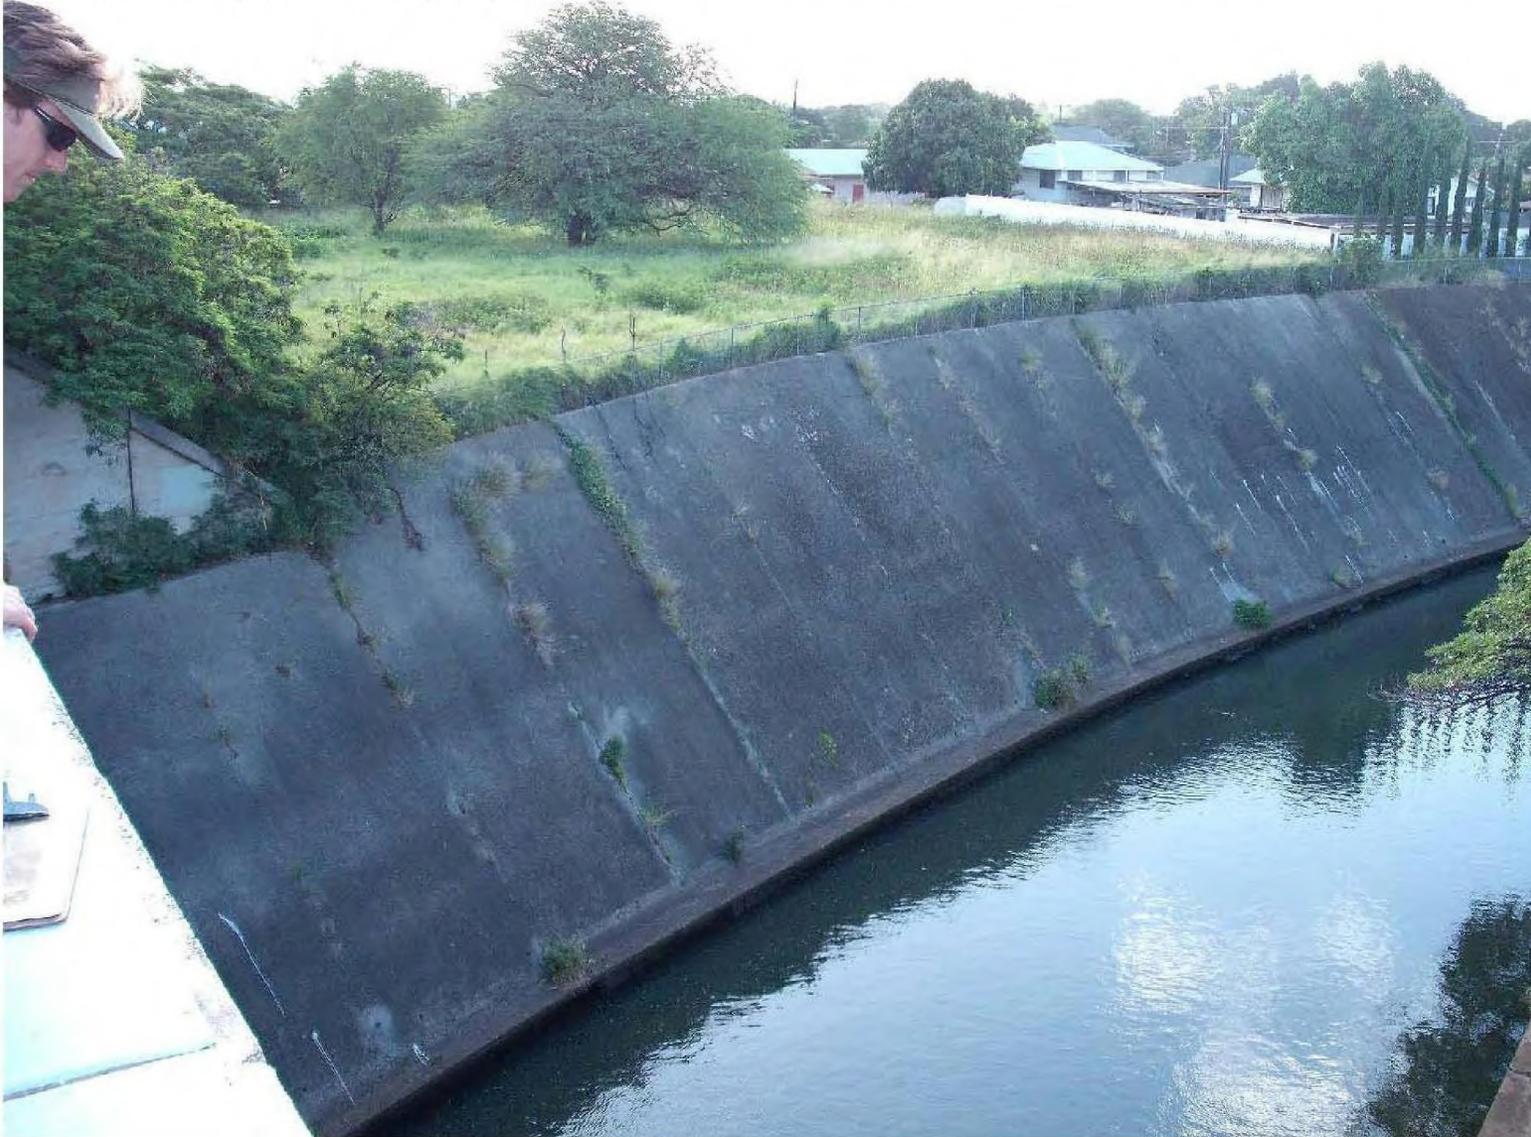
Site 8 was visited on 3-26-09 at 8:30 a.m. under conditions of clear skies and no recent rainfall as documented in the following photograph. The site was revisited on 7-05-09. On the left bank of Waikele Stream, facing south from Farrington Highway, is a large vacant and highly vegetated lot (Site 8) where soil maps indicate a soil type associated with wetlands. However, Site 8 was determined not to be a wetland due to the observation of upland plant species being the dominant vegetation and no indicators of saturation or surface hydrology. In addition, the site is at least 30 feet above the Waikele Stream and separated by a concrete retaining wall.

Photo 8A: The lot adjacent to the Waikēle Stream is listed as having potentially hydric soils. The dry character and high elevation of the land above the stream, combined with the absence of wetland vegetation, rule out this property as a wetland.
