# HISTORY AND STATUS OF THE MOILIILI KARST, HAWAII

WILLIAM R. HALLIDAY

*The Moiliili Karst occurs in Pleistocene reef limestone located in a populous, low-elevation area of Honolulu, Hawaii. A 1934 construction excavation intersected a previously unknown karstic master conduit at a depth of -7 m msl. Temporary dewatering of over  $3.7 \times 10^9$  L caused considerable economic loss due to collapses and subsidences in a wedge-shaped area about 1 km on each side. These outline a previously unrecognized dendritic karst drainage. Considerable retrograde flow of salt water also occurred. Subsequent urbanization again lowered the water table and dewatering phenomena are still occurring. A section of Moiliili Water Cave is the only clearly karstic feature that remains available for study. It serves as a floodwater conduit. Surprisingly, its water quality has improved since 1983. Its protection should be a prototype for other Hawaiian karsts and pseudokarsts. Other sections of Honolulu also are underlain by reef limestone and may be at risk.*

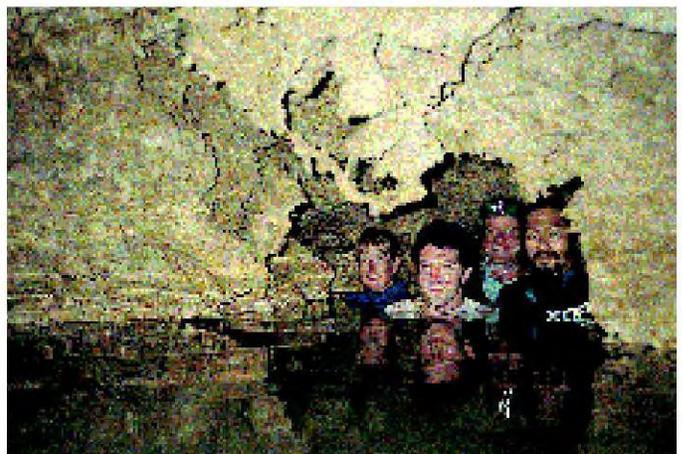
**Figure 4. Solutional features, Moiliili Water Cave. Nearby water depth is 2 meters, so helmets are not worn.**

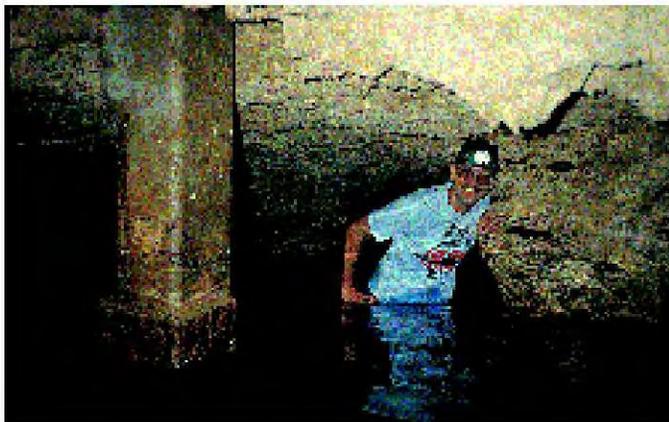
**Figure 5. Metal piling in main passage, Moiliili Water Cave.**
