**Archaeological Inventory Survey Report
For City Center (Section 4) of the
Honolulu High-Capacity Transit Corridor Project,
Kalihi, Kapālama, Honolulu, and Waikīkī Ahupua‘a,
Honolulu (Kona) District, Island of O‘ahu
TMK [1] 1-2, 1-5, 1-7, 2-1, 2-3 (Various Plats and Parcels)**

**Prepared by
Hallett H. Hammatt, Ph.D.**

**Cultural Surveys Hawai‘i, Inc.
Kailua, Hawai‘i
(Job Code: KALIHI 23)**

April 2013

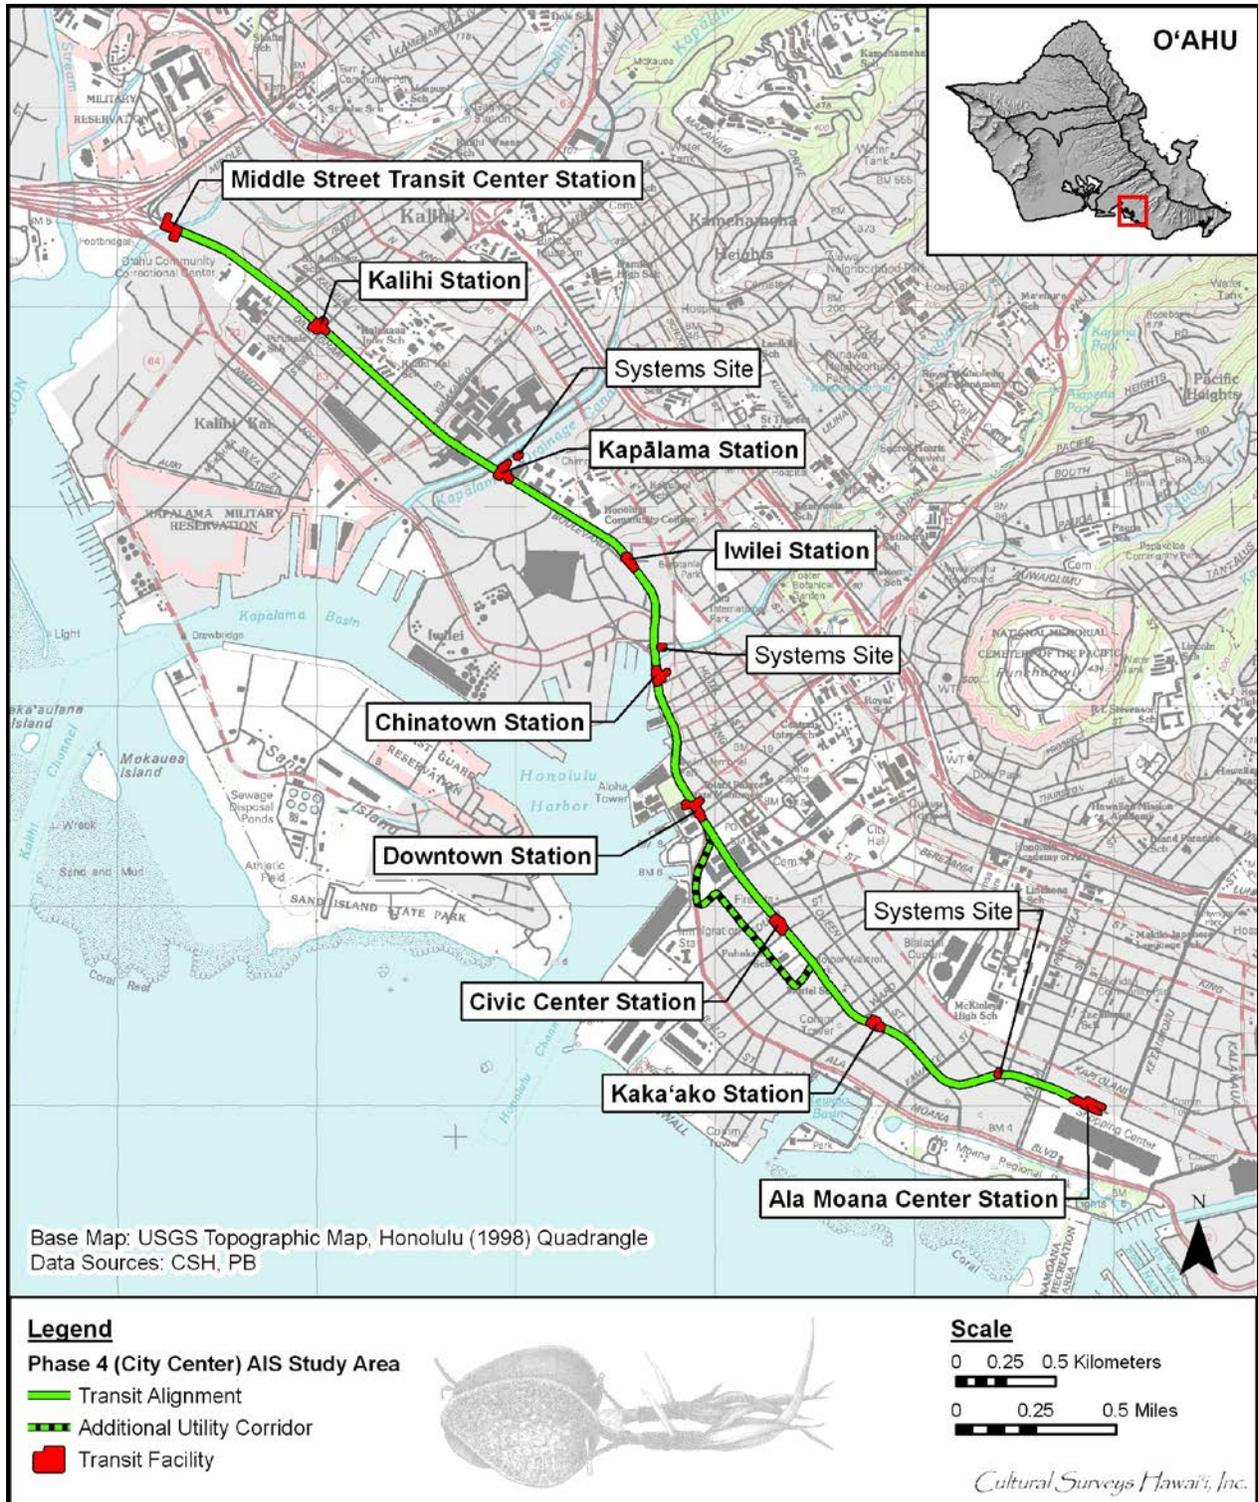
Figure 2. Portion of the 1998 Honolulu U.S.G.S. 7.5-minute topographic quadrangle showing the City Center alignment and related transit facilities

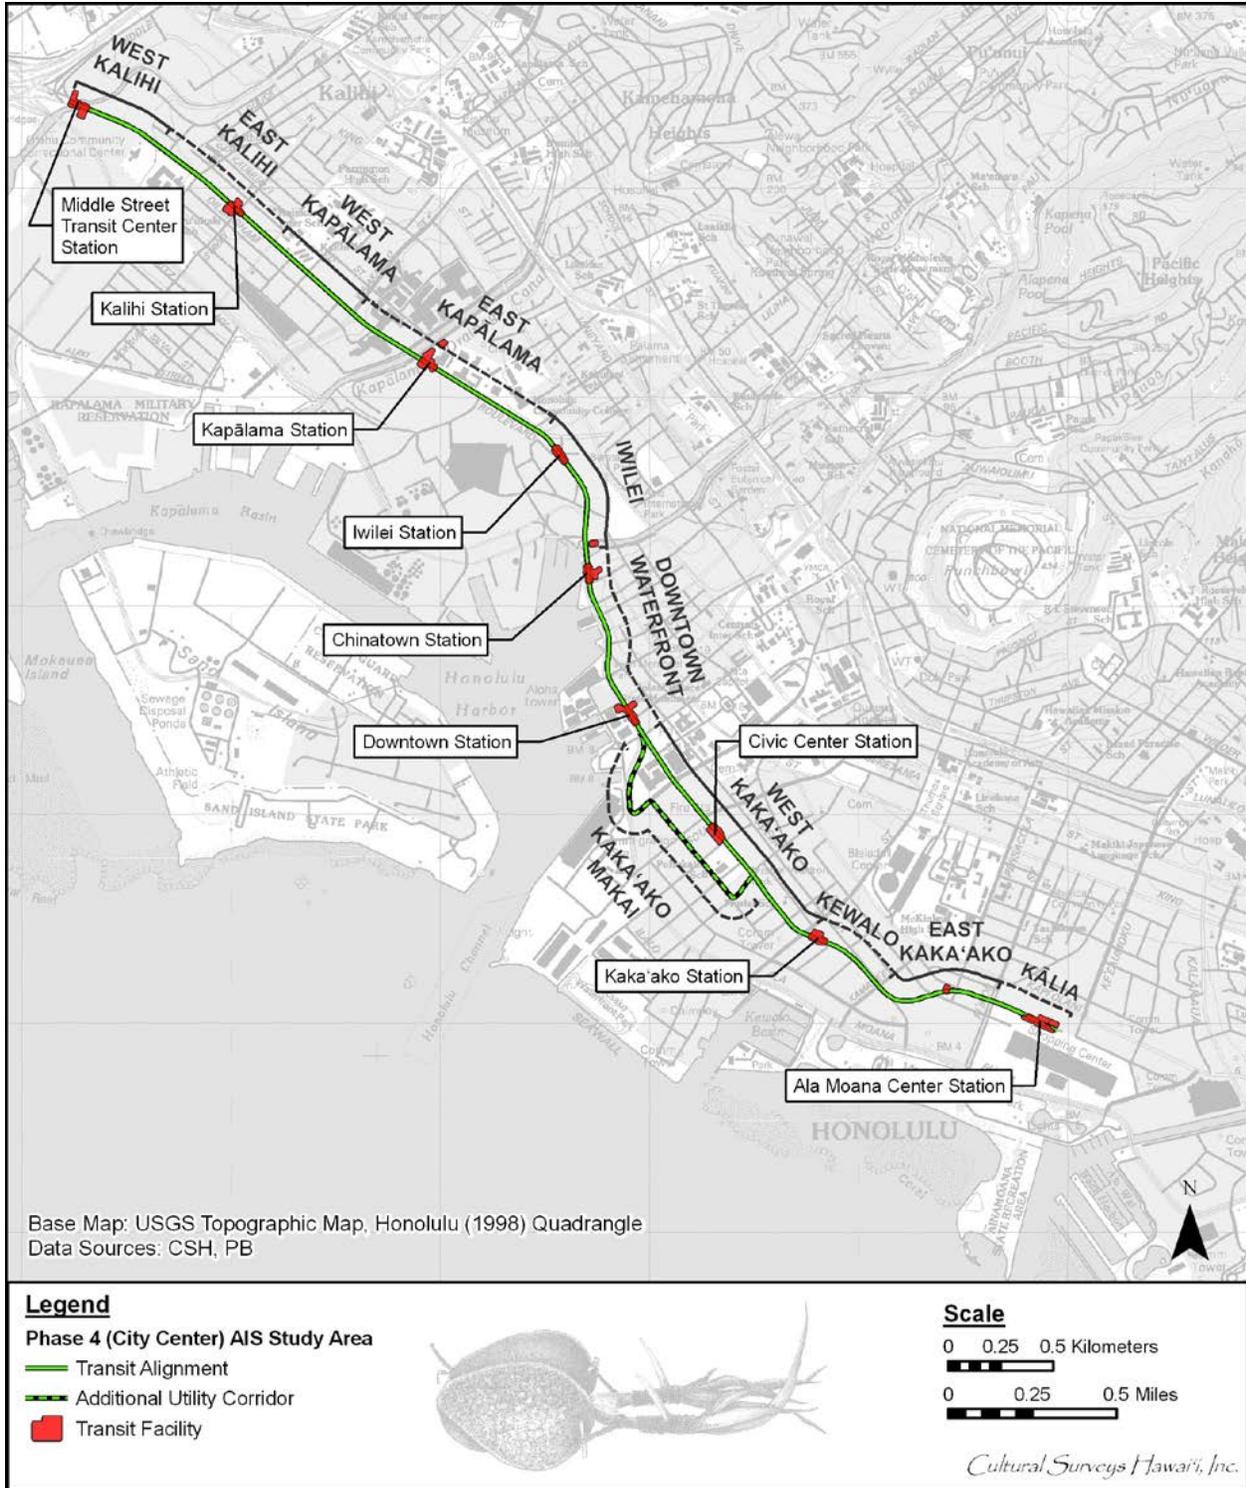
Figure 9. Portion of the 1998 Honolulu U.S.G.S. 7.5-minute topographic quadrangle showing City Center's 11 geographic zones along with the nine City Center Stations

The West Kalihi Geographic Zone is within Kalihi Ahupua'a, along the eastern margins of Kalihi Stream. Observed stratigraphy in test excavations consisted of relatively thick fill layers over Kalihi Stream estuary sediments found near the water table. Elevations are typically low, 1.5 to 3 meters above mean sea level. West Kalihi extends approximately 0.5 km along Kamehameha Highway and is bounded to the west by the Middle Street exit from Kamehameha Highway and on the east by Laumaka Street. West Kalihi's eastern boundary is the edge of the emerged Pleistocene reef limestone common along southern O'ahu. The West Kalihi Geographic Zone is distinct from the immediately adjacent geographic zones to the east because of the estuary sediments encountered.

From West Kalihi, the AIS study area ascends slightly up onto the Pleistocene reef limestone formed during the 7.5 m (Waimānalo) sea-stand (Macdonald et al. 1983:420–421). Both the East Kalihi and West Kapālama Geographic Zones are situated on this slightly elevated limestone surface. Elevations increase from the relatively low-lying Kalihi Estuary to 4.75 to 7.25 m above mean sea level. East Kalihi extends approximately 0.7 km along Kamehameha Highway and Dillingham Boulevard, from Laumaka Street on the west to Kalihi Street on the east. The West

Kapālama Geographic Zone extends approximately 0.5 km along Dillingham Boulevard and is bounded to the west by Kalihi Street and to the east by Waiakamilo Road. In both East Kalihi and West Kapālama similar stratigraphy was observed in test excavations: relatively thin fill layers, over 'Ewa silty clay loam alluvium, over the Pleistocene coral limestone bedrock. In many areas, this bedrock was less than a meter below the current ground surface. At the eastern boundary of the West Kapālama Zone, at Waiakamilo Road, this limestone bedrock is exposed on the surface. The boundary between East Kalihi and West Kapālama is Kalihi Street, which follows generally the traditional Hawaiian land division between Kalihi and Kapālama Ahupua'a.

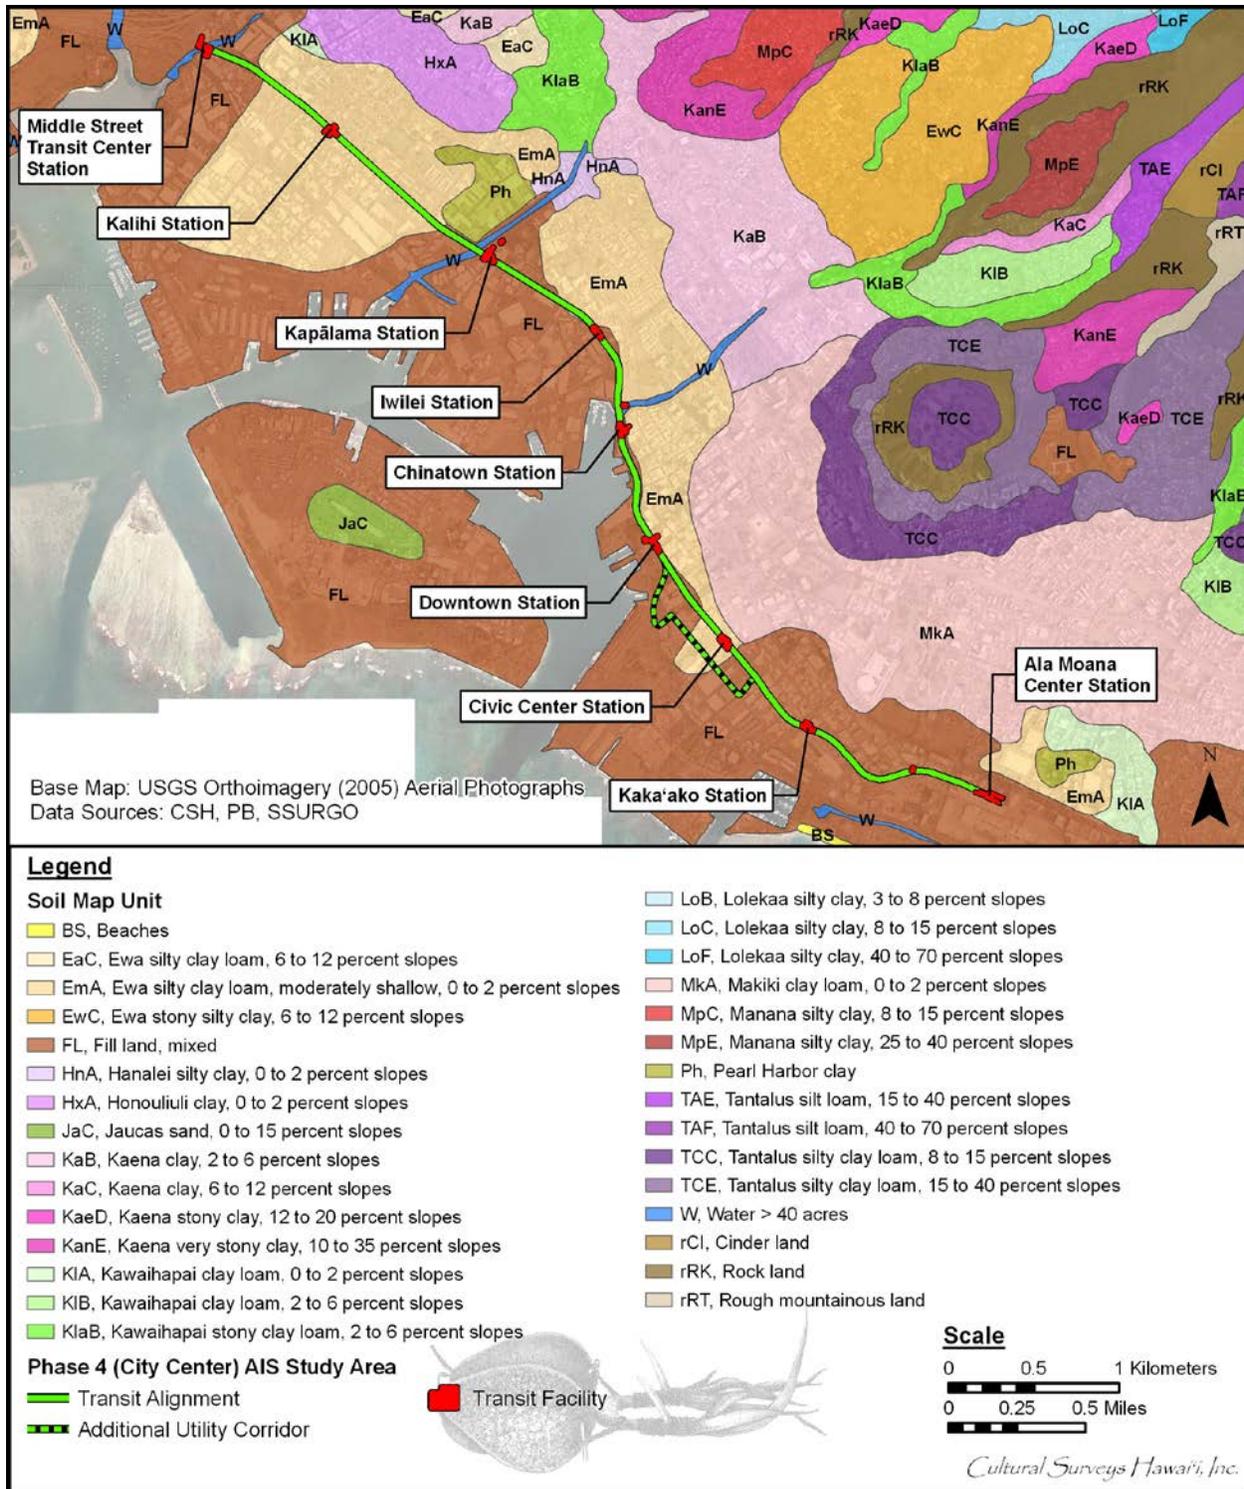
Figure 10. Aerial photograph (source: U.S.G.S. orthoimagery 2005) with overlay of the Soil Survey of Hawai'i (Foote et al. 1972), showing USDA soil types in the vicinity of the City Center AIS study area

This soil occurs on alluvial fans and terraces...Permeability is moderate. Runoff is slow, and the erosion hazard is slight...The depth to coral limestone or gravelly alluvium ranges from 50 to more than 60 inches. In some areas cobble stones and stones occur on the surface and in the surface layer. This soil is used for sugarcane, truck crops and pasture. (Foote et al. 1972:29–3)
