Section 2 Zone 9 East Kaka'ako (Test Excavations 179 to 197)

For reporting purposes for this AIS, the City Center Section 4 of the Honolulu High-Capacity Transit Corridor Project (HHCTCP) has been divided into 11 zones based on geographical and cultural boundaries. The East Kaka'ako Geographic Zone extends from Kamake'e and Queen Streets at the west end, through Waimanu and Pensacola Streets, and follows Kona Street to Pi'ikoi Street, which marks the east end (Figure 2). The central portion of this zone lies within the historic Kolowalu Fishpond (see Volume II). The East Kaka'ako Zone corridor is located entirely within Honolulu Ahupua'a. Pi'ikoi Street marks the *ahupua'a* boundary between Honolulu and Waikiki Ahupua'a.

The East Kaka'ako Zone includes 19 AIS Test Excavations numbered T-179 through T-197 (T-197 was abandoned because it was located in an existing building; however, T-196 was placed in the immediate vicinity of T-197, between the straddle-bent columns and within the utility relocation corridor, and pertinent information was collected from this area). Test excavations were generally numbered from west to east. The Test Excavations within the East Kaka'ako Zone were

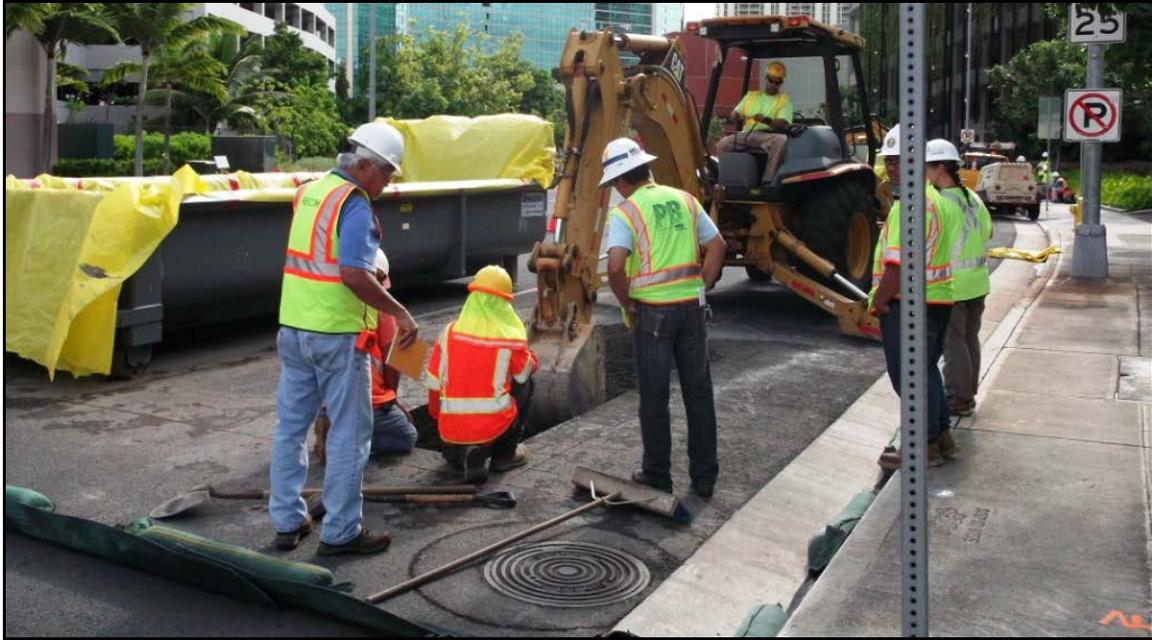
T-179 general location, view to east

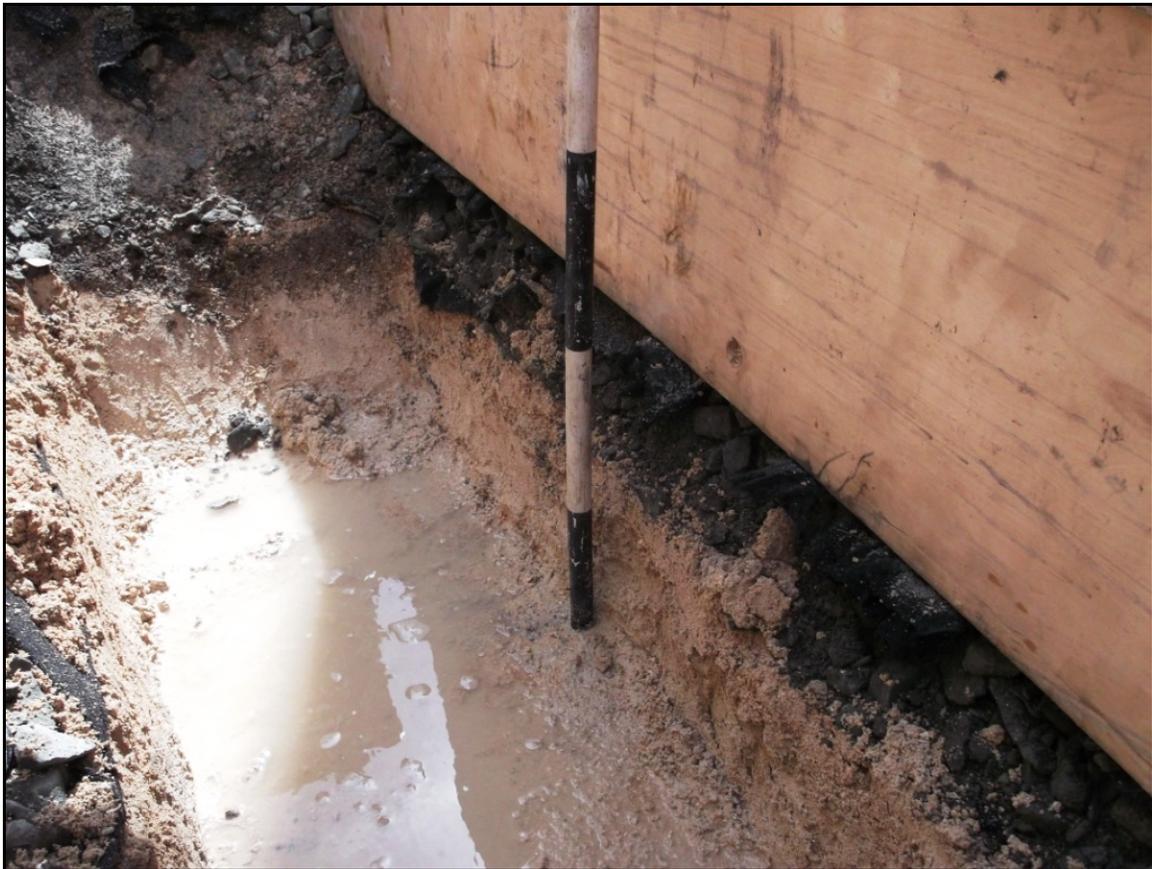
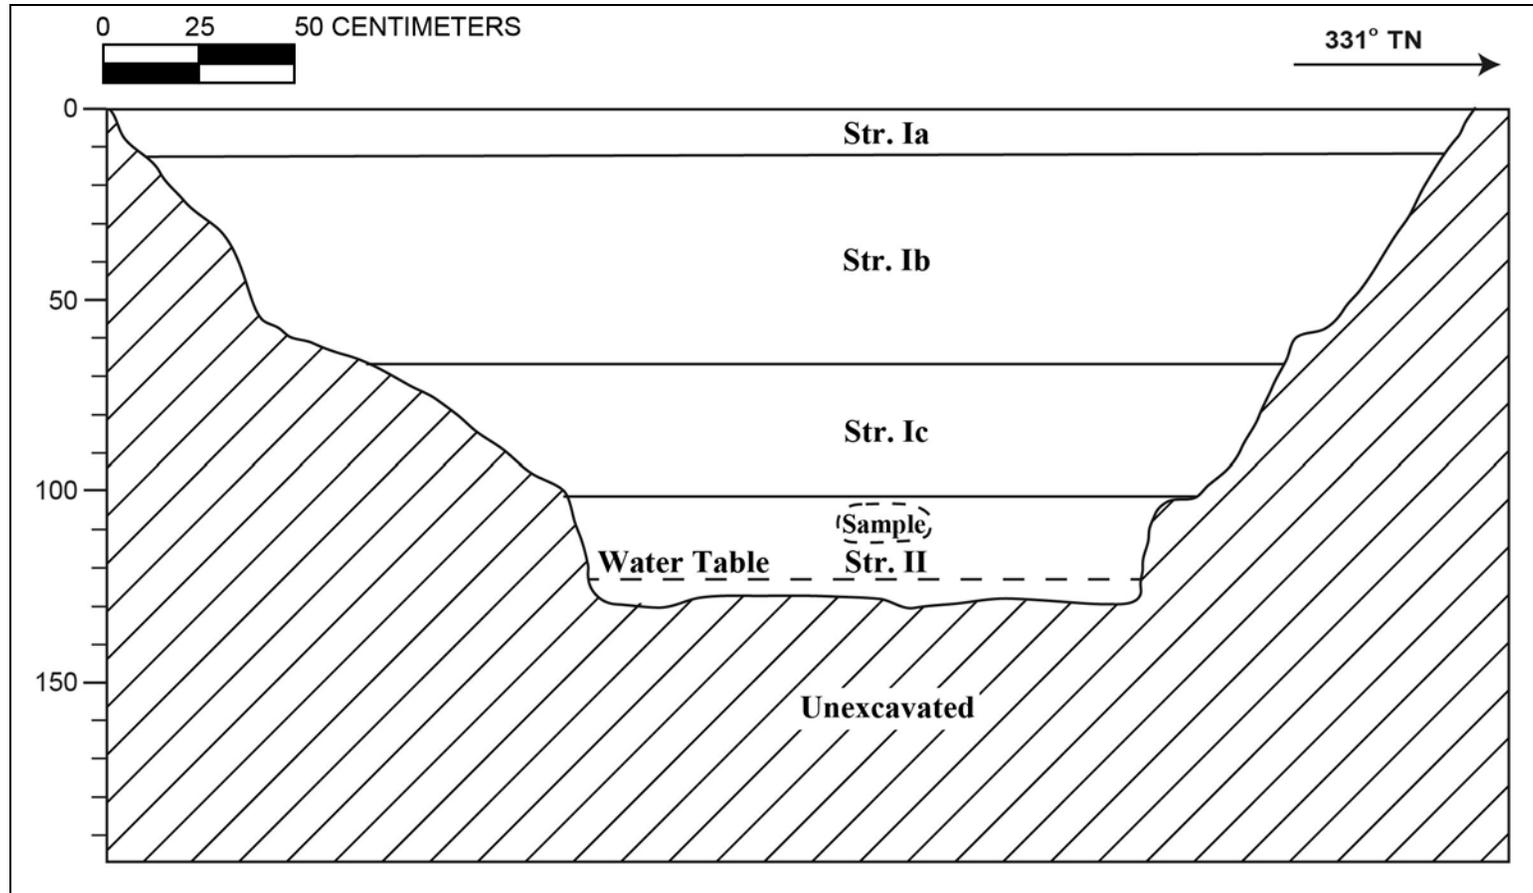
Stratigraphic Summary: The stratigraphy at T-179 consisted of fill overlying natural sediment. Observed strata included asphalt (Ia), gravel base course (Ib), coarse cobble layer (Ic), and natural marine sand (II). The stratigraphy generally conformed to the USDA soil survey designation of Fill land (FL).

Summary: T-179 was excavated to the water table at a depth of 1.26 mbs. The stratigraphy of T-179 consisted of fill (Ia–Ic) overlying natural sediment (II). The stratigraphy generally conformed to the USDA soil survey designation of Fill land (FL). A bulk sediment sample was collected from Stratum II between 1.05–1.15 mbs (4.5 L). The bulk sample was wet-screened and contained natural marine shell and shell fragments. The results of sample analysis support the identification of Stratum II as a natural marine deposit. No archaeological cultural resources were identified within T-179.

T-179 southwest profile wall, view to south

T-179 southwest wall profile

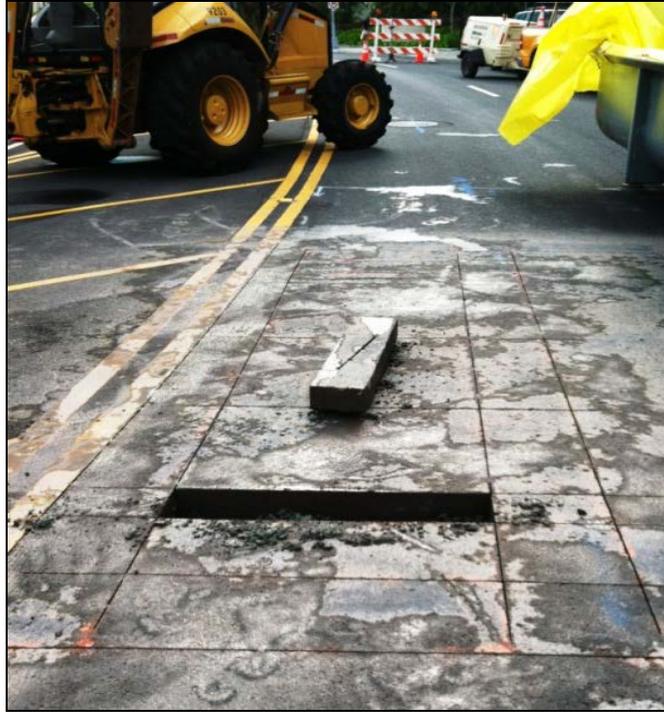
T-180 general location, view to southeast

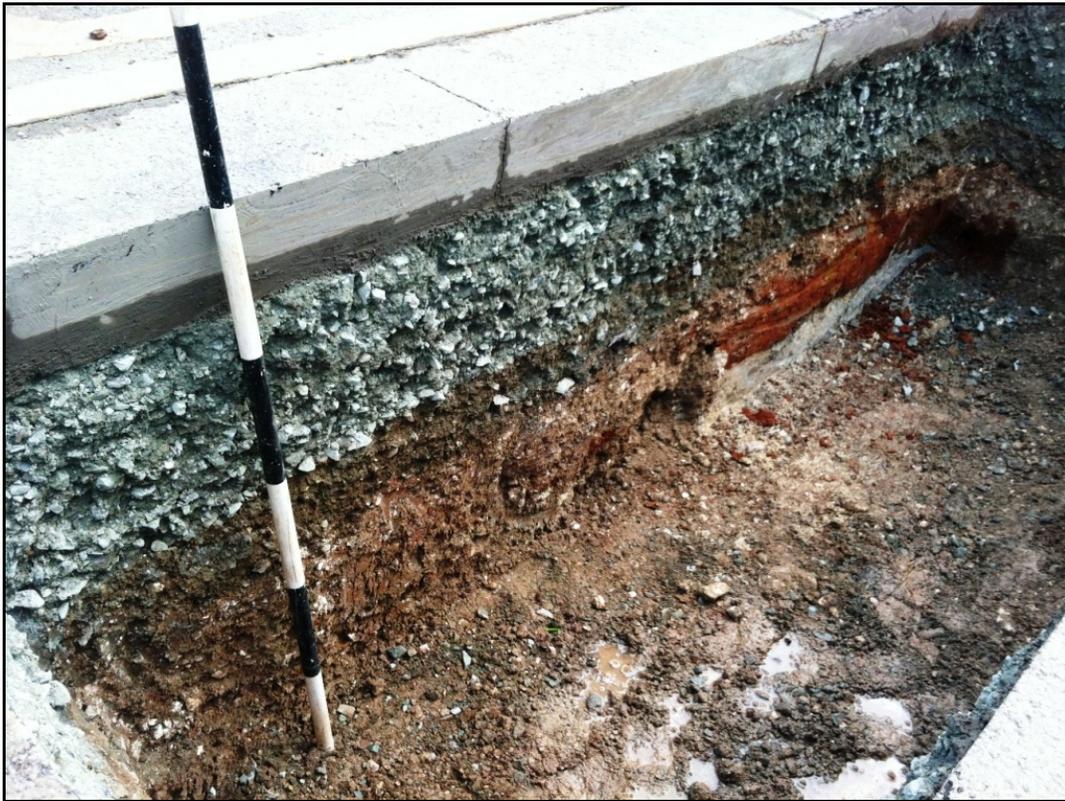
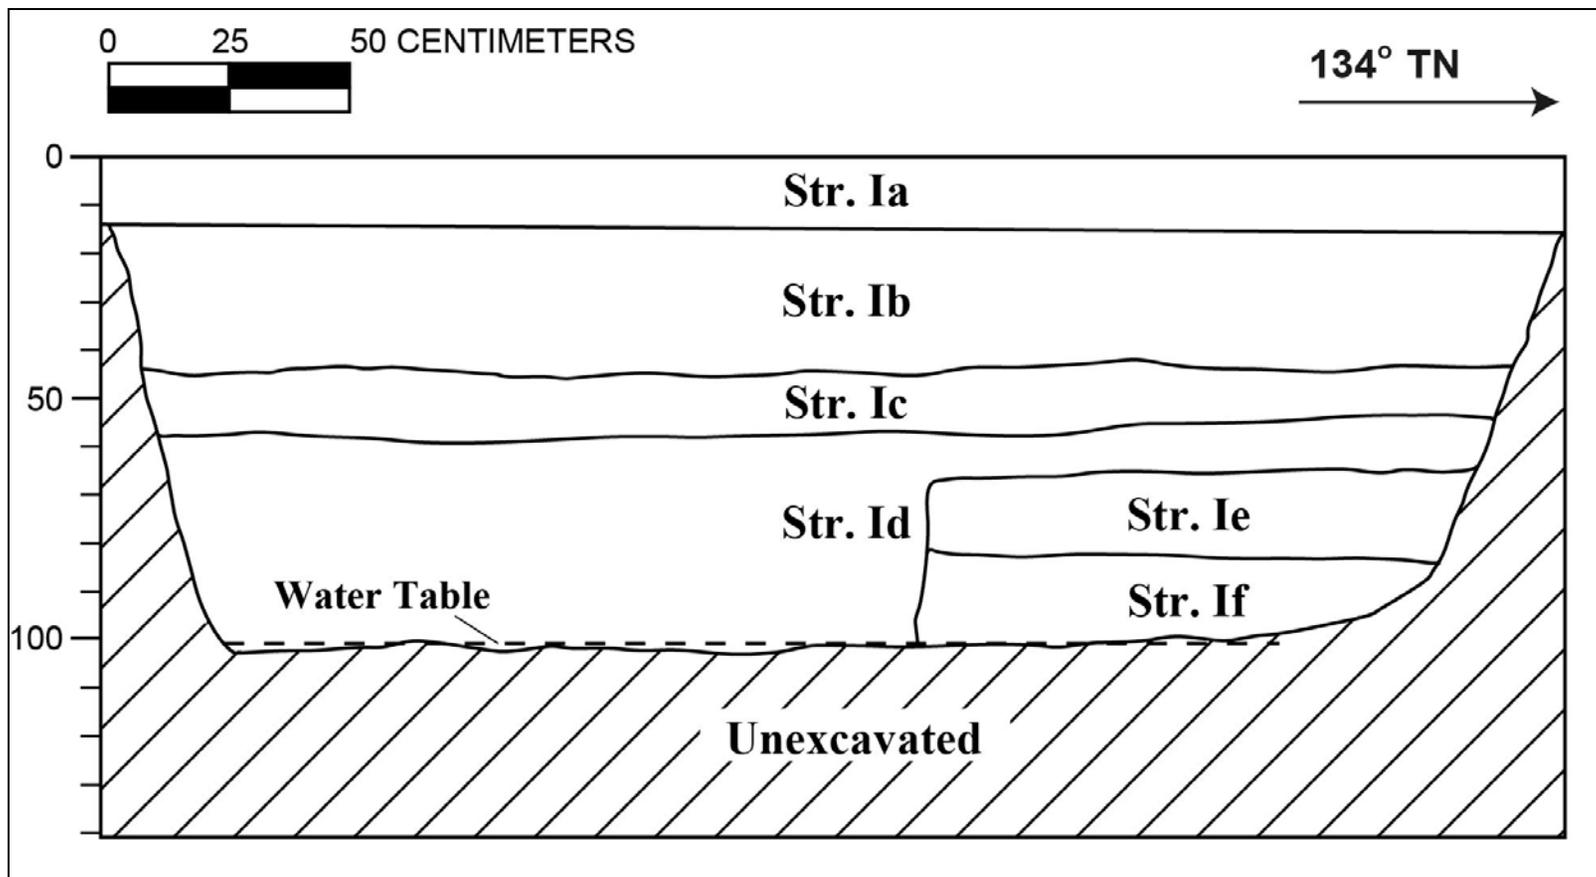
Stratigraphic Summary: The stratigraphy at T-180 consisted of fill to the water table. Observed strata included asphalt (Ia), crushed gravel base course (Ib), very gravelly sandy loam (Ic and Id), loamy clay (Ie), and sandy clay loam (If). The stratigraphy conformed to the USDA soil survey designation of Fill land (FL).

Summary: T-180 was excavated to beneath the water table at a depth of 1.04 mbs. The stratigraphy at T-180 consisted of fill (Ia-If) to the base of excavation. The stratigraphy conformed to the USDA soil survey designation of Fill land (FL). No natural sediment was observed. No cultural materials were identified within T-180.

T-180 northeast profile wall, view to east

T-180 northeast wall profile

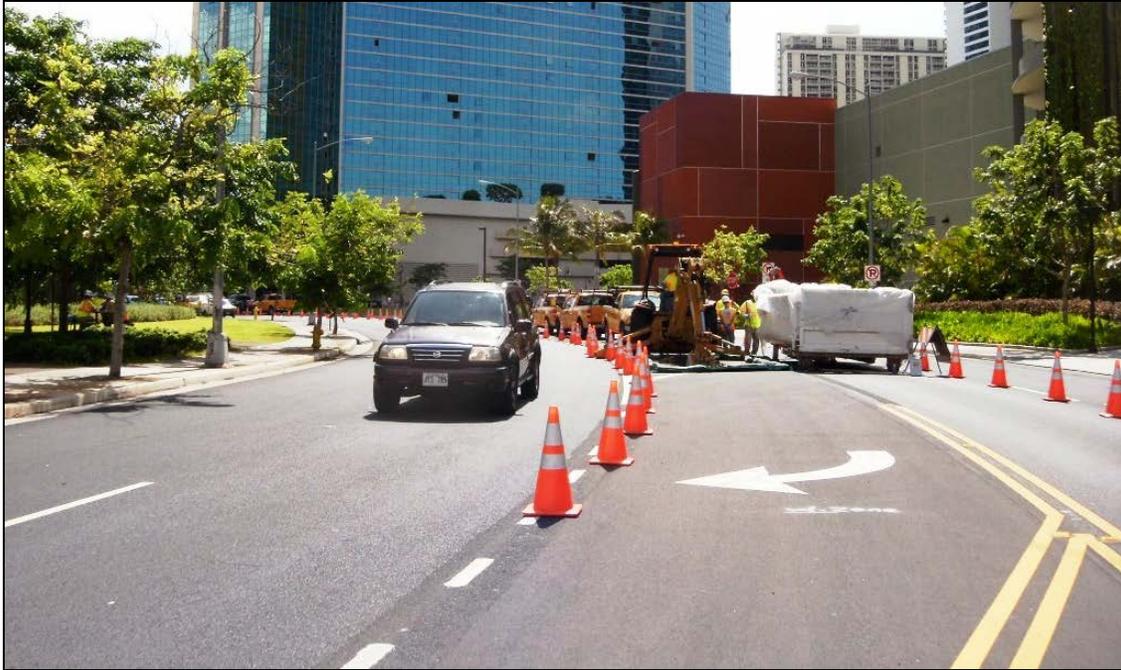
T-181 general location, view to east

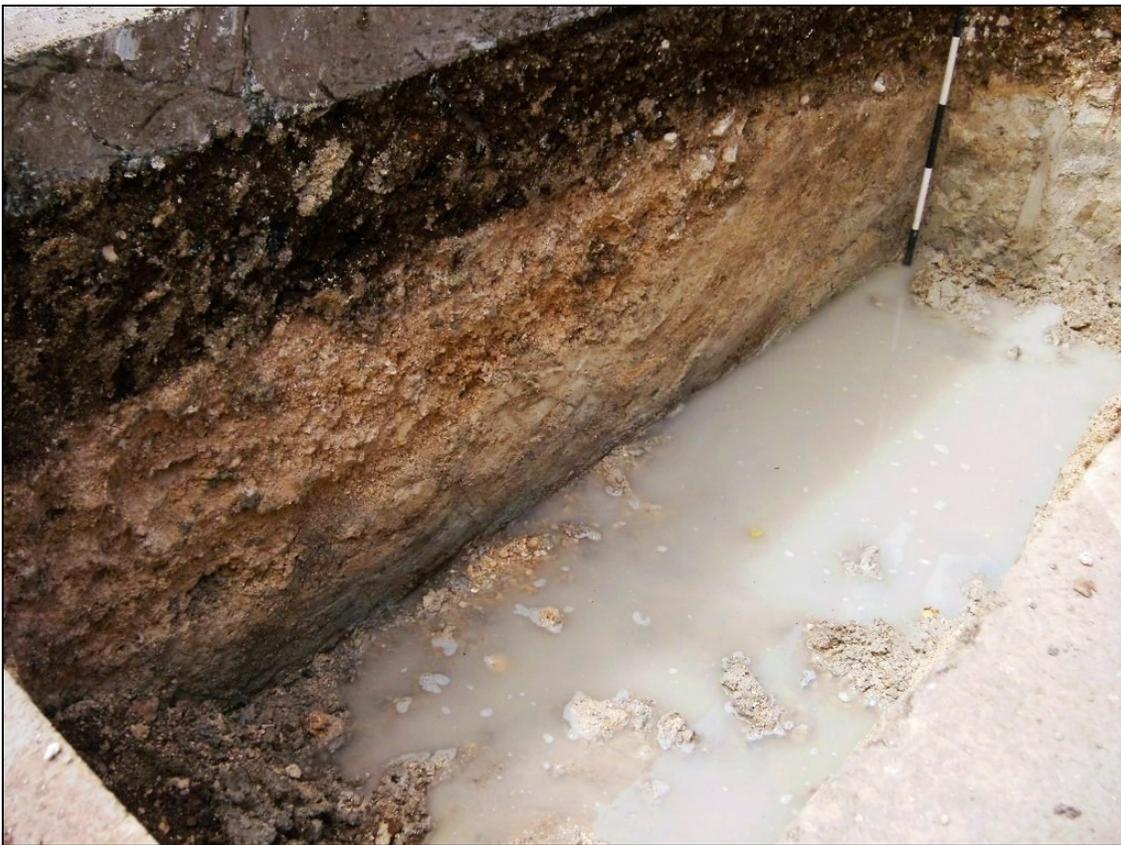
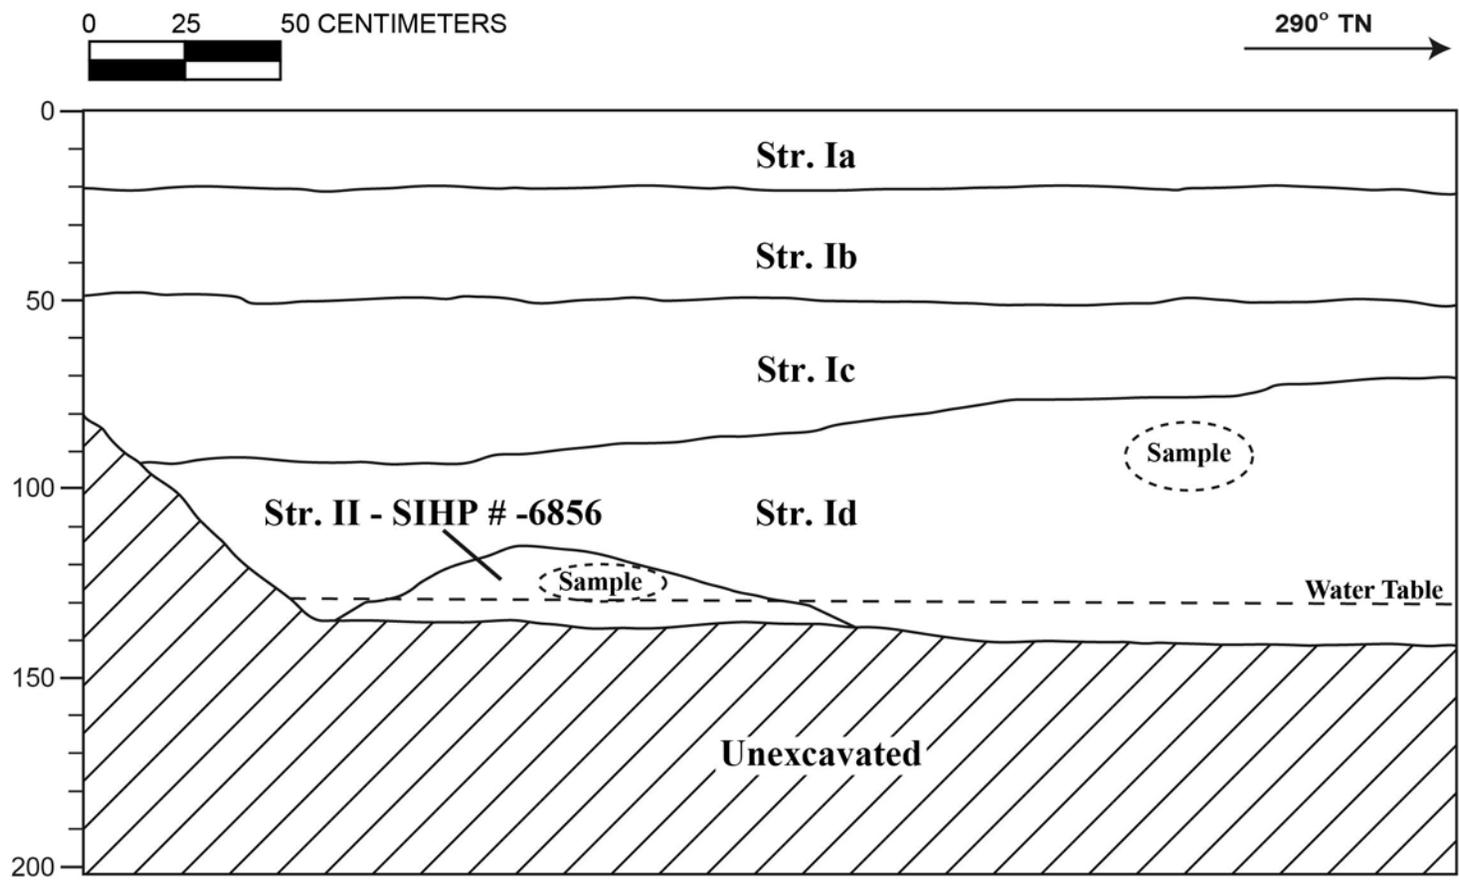
Stratigraphic Summary: The stratigraphy at T-181 consisted of fill overlying natural sediment to the beneath the water table. Observed strata included asphalt (Ia), gravel base course (Ib), crushed coral fill (Ic), and locally-procured sandy clay fill (Id) overlying natural sandy clay (II). The stratigraphy generally conformed to the USDA soil survey designation of Fill land (FL). Stratum II contained lenses of peat material and common, fine roots. The results of sample analysis appeared to document the natural deposition of marine shell within a backshore wetland environment during storm or tidal events.

Summary: T-181 was excavated to a depth of 1.40 mbs and beneath the water table at 1.3 mbs. The stratigraphy at T-181 consisted of fill (Ia to Id) overlying natural sediment (II) to the beneath the water table. The stratigraphy generally conformed to the USDA soil survey designation of Fill land (FL). A total of two bulk sediment samples were collected from T-181, including a sample of Stratum Id between 0.8–1.0 mbs (1 L) and one from Stratum II between 1.20–1.30 mbs (0.5 L). The bulk samples were wet-screened yielding only naturally-occurring, water-rounded marine shell. The results of sample analysis appeared to document the natural deposition of marine shell within a backshore wetland environment during storm or tidal events (St. II). T-181 was located within the previously established boundary of Kolowalu Fishpond (SIHP #50-80-14-6856).

T-181 south profile wall, view to southwest

T-181 south wall profile

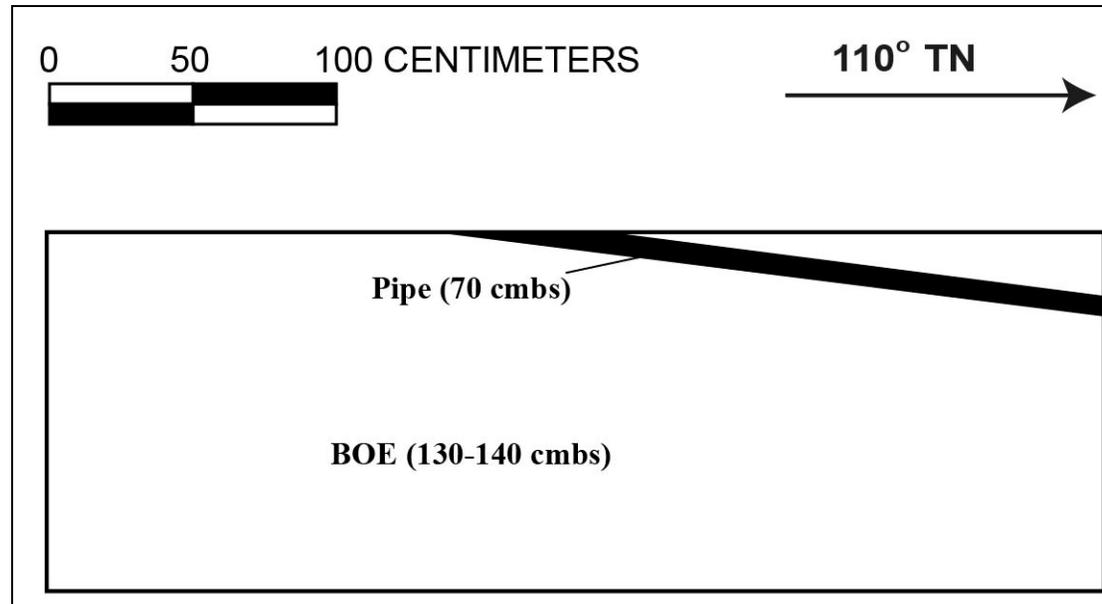
GPR Discussion: Although a review of amplitude slice maps indicated a linear feature, none were encountered during excavation. An irrigation line, however, was encountered below the clean signal return. Reflectivity was relatively uniform throughout the grid and decreased with depth except for the linear feature detected by the GPR. A transition from higher reflectivity to lower reflectivity was observed at approximately 0.25 mbs and increased again around 0.75 mbs.

T-181 post-excavation plan view showing the base of excavation (BOE) and the location of a PVC irrigation pipe

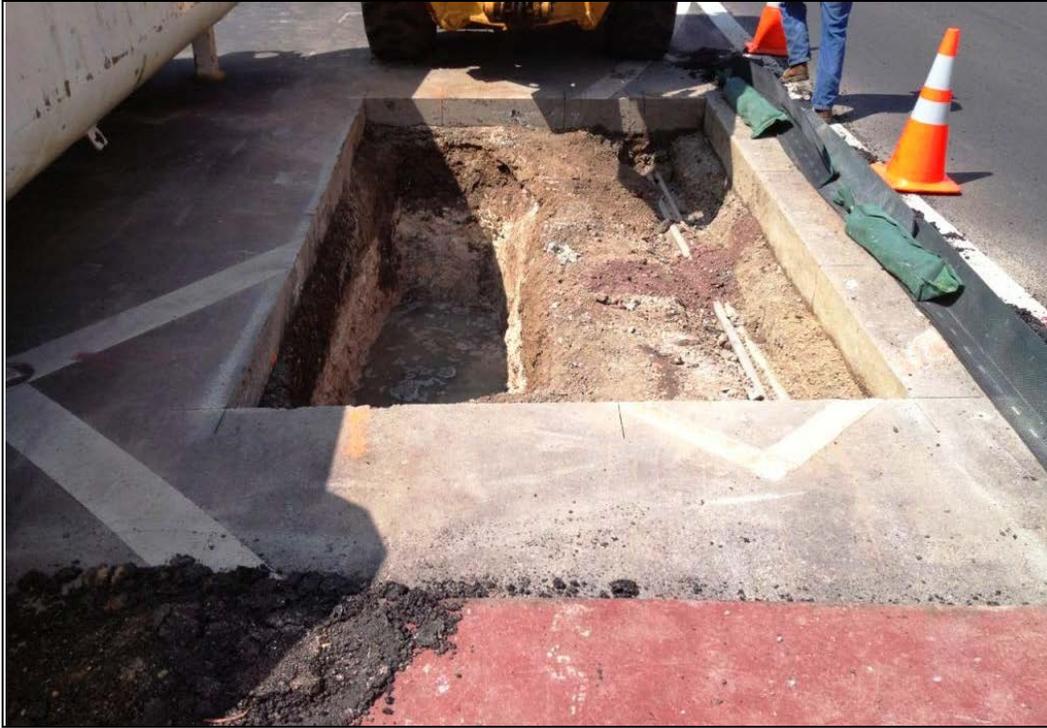
T-182 general location, view to west

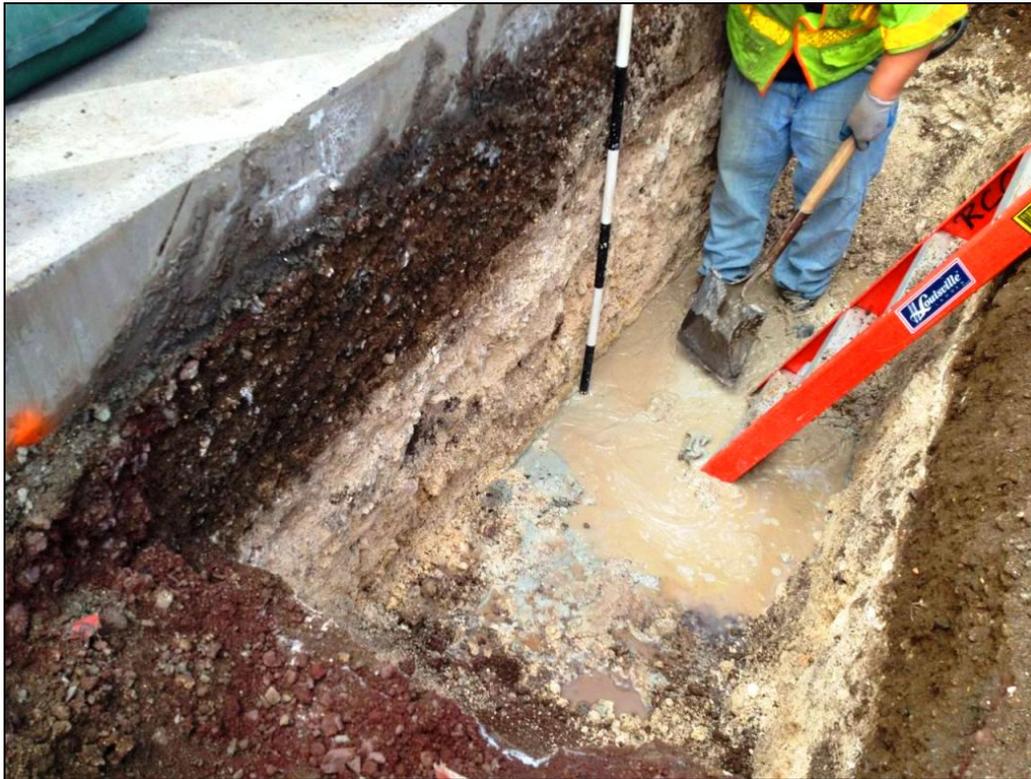
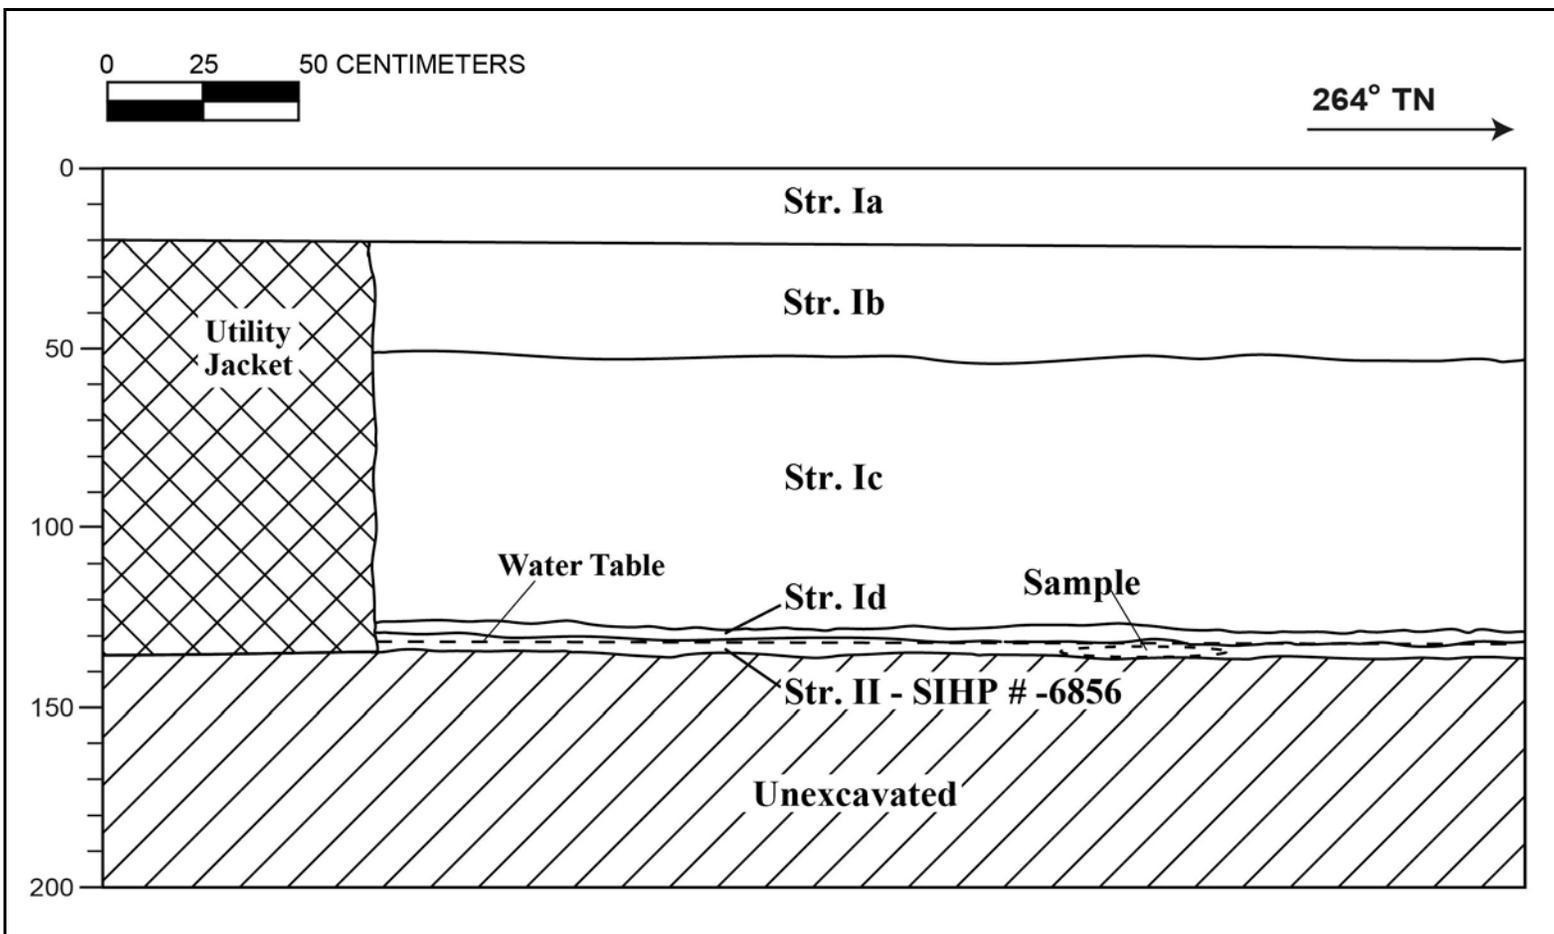
Stratigraphic Summary: The stratigraphy of T-182 consisted of fill overlying natural sediment. Observed strata included asphalt (Ia), very gravelly sandy loam fill (Ib), stony crushed coral sand fill (Ic), and fine sand fill (Id), overlying natural sandy clay (II) to the water table. The stratigraphy generally conformed to the USDA soil designation of Fill land (FL).

Summary: T-182 was excavated to a depth of 1.38 mbs and below the water table at 1.31 mbs. The stratigraphy of T-182 consisted of fill (Ia to Id) overlying natural sediment (II). The stratigraphy generally conformed to the USDA soil designation of Fill land (FL). One bulk sediment sample was collected from Stratum II between 1.29–1.38 mbs (2 L). The bulk sample was wet-screened yielding only naturally-occurring, water-rounded marine shell. The results of sample analysis appeared to document the natural deposition of marine shell within a backshore wetland environment during storm or tidal events (St. II). T-182 was located within the previously established boundary of Kolowalu Fishpond (SIHP #50-80-14-6856).

T-182 south profile wall, view to southwest

T-182 north wall profile

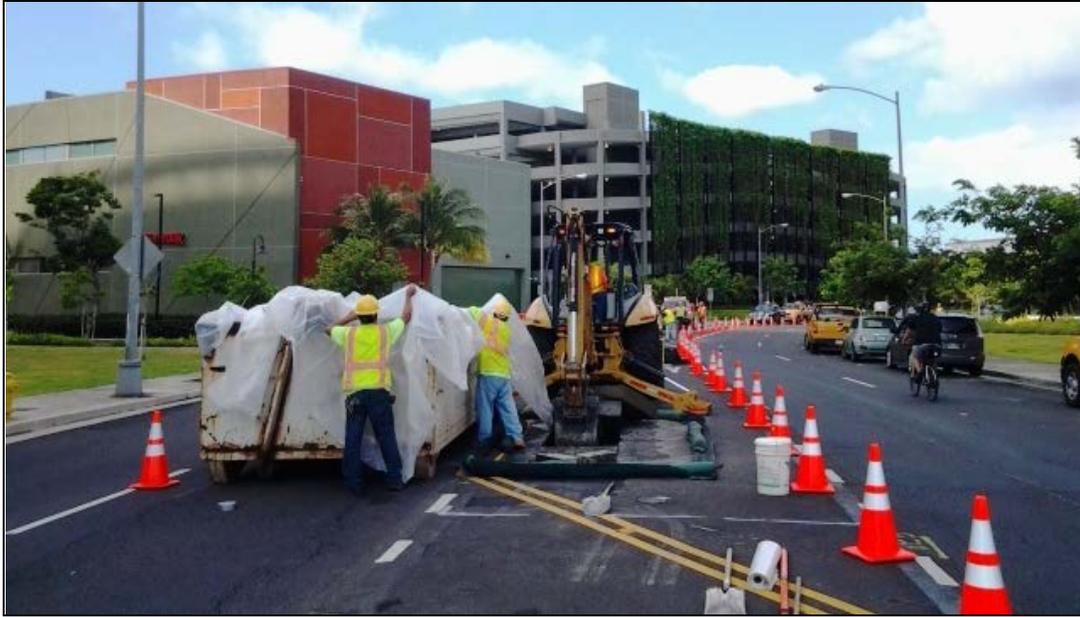
T-183 general location, view to west

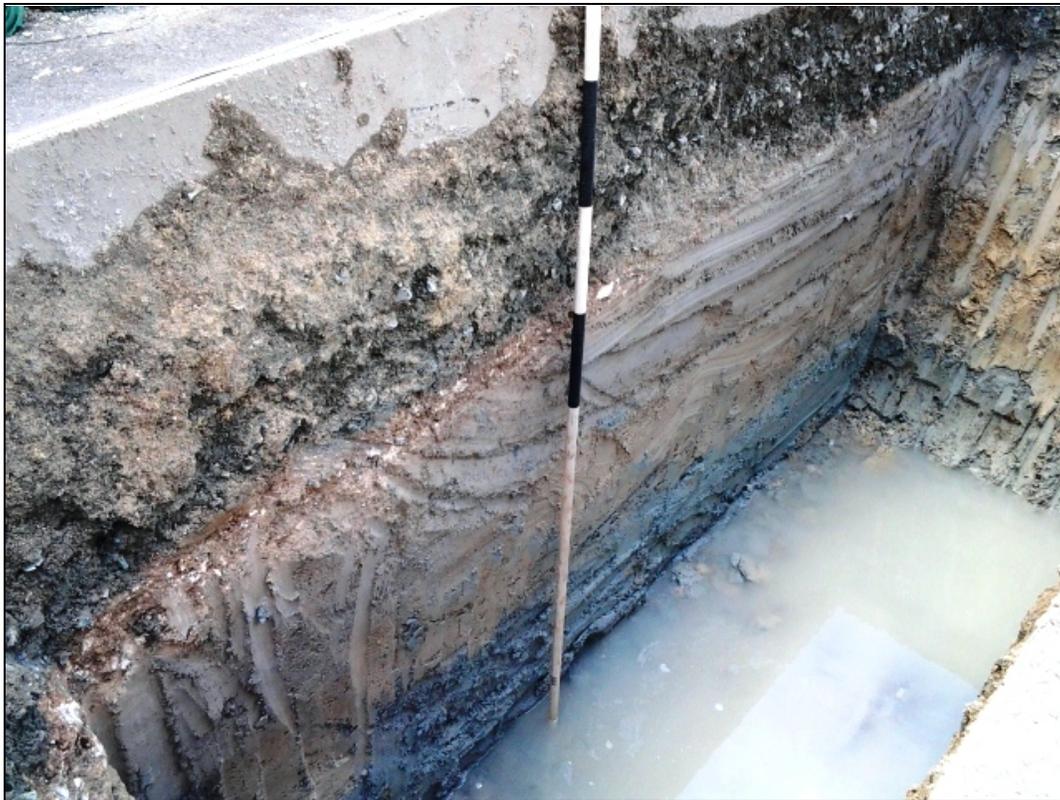
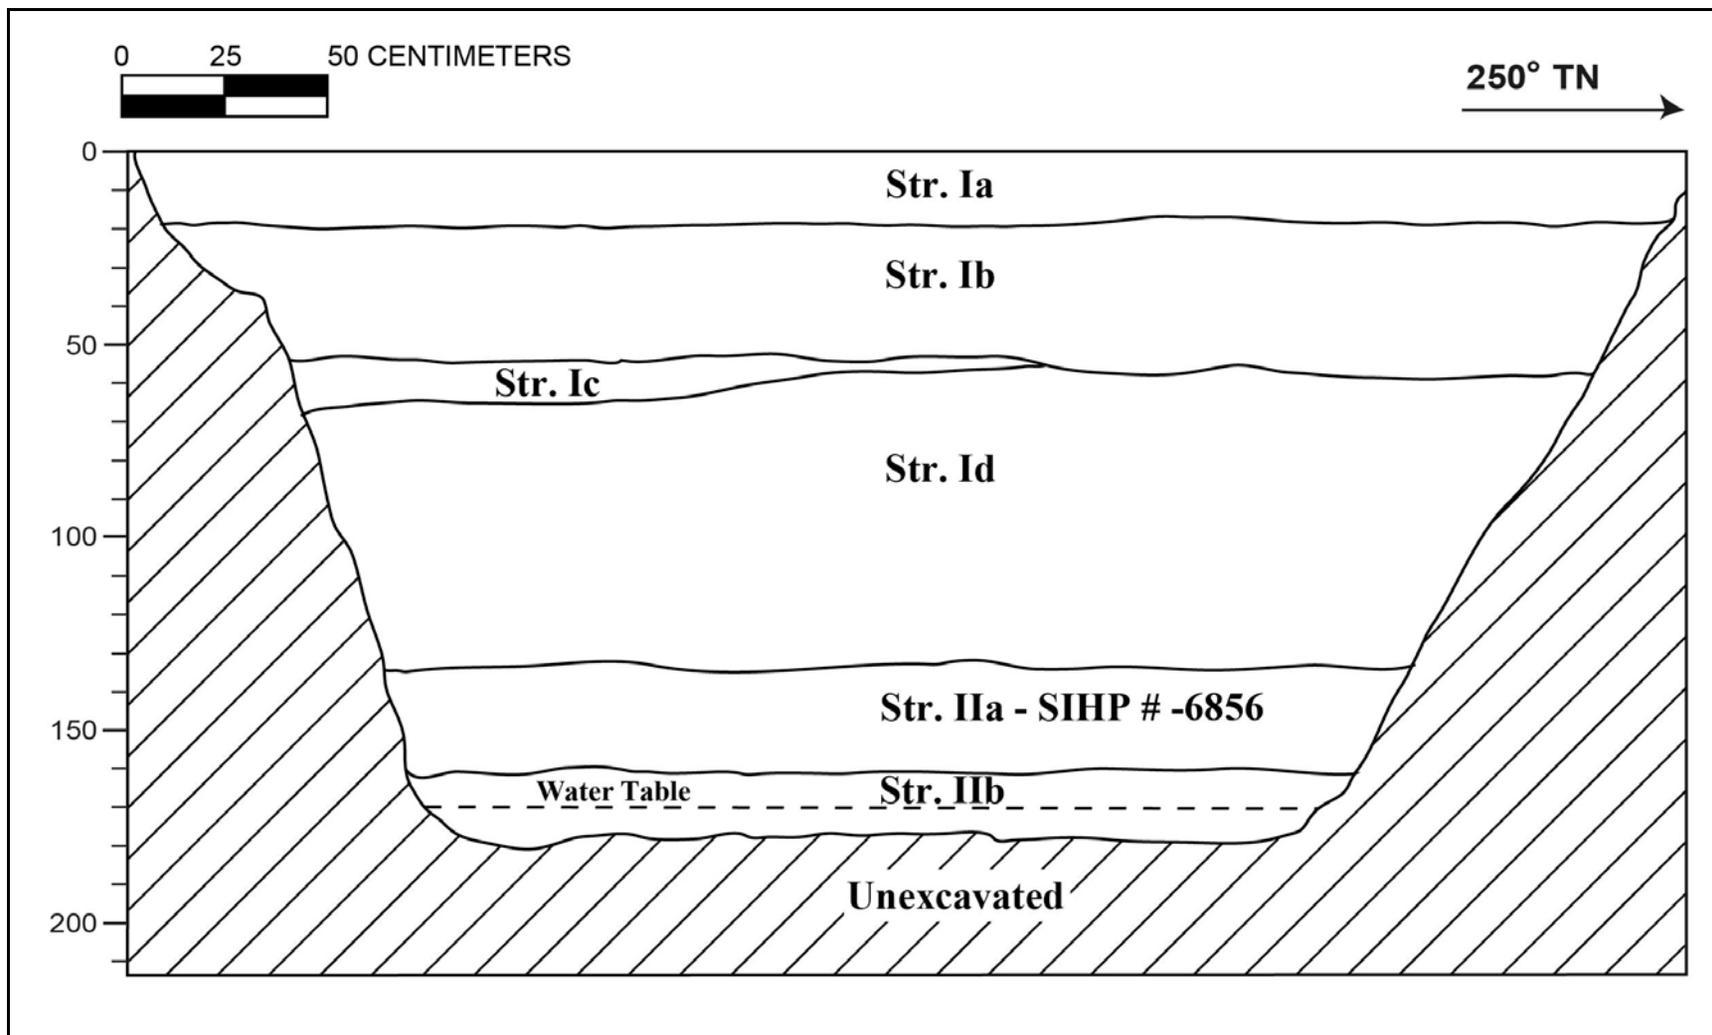
Stratigraphic Summary: The stratigraphy of T-183 consisted of fill overlying natural sediment to beneath the water table. Observed strata included asphalt (Ia), extremely gravelly sandy silt base course (Ib), gravelly sandy loam fill (Ic), and hydraulic fill (Id), overlying natural clay (IIa) and natural sand (IIb). The stratigraphy generally conformed to the USDA soil survey designation of Fill land (FL). The results of sample analysis appeared to document the natural deposition of marine shell within a backshore wetland environment during storm or tidal events.

Summary: T-183 was excavated to a depth of 1.80 mbs and beneath the water table at 1.70 mbs. The stratigraphy of T-183 consisted of fill (Ia to Id) overlying natural sediment (IIa and IIb) to beneath the water table. The stratigraphy generally conformed to the USDA soil survey designation of Fill land. T-183 was located within the previously established boundary of Kolowalu Fishpond (SIHP #50-80-14-6856). The natural sediment (IIa) within T-183 was considered to be a possible remnant of Kolowalu Fishpond (SIHP #50-80-14-6856).

T-183 south profile wall, view to southwest

T-183 south wall profile

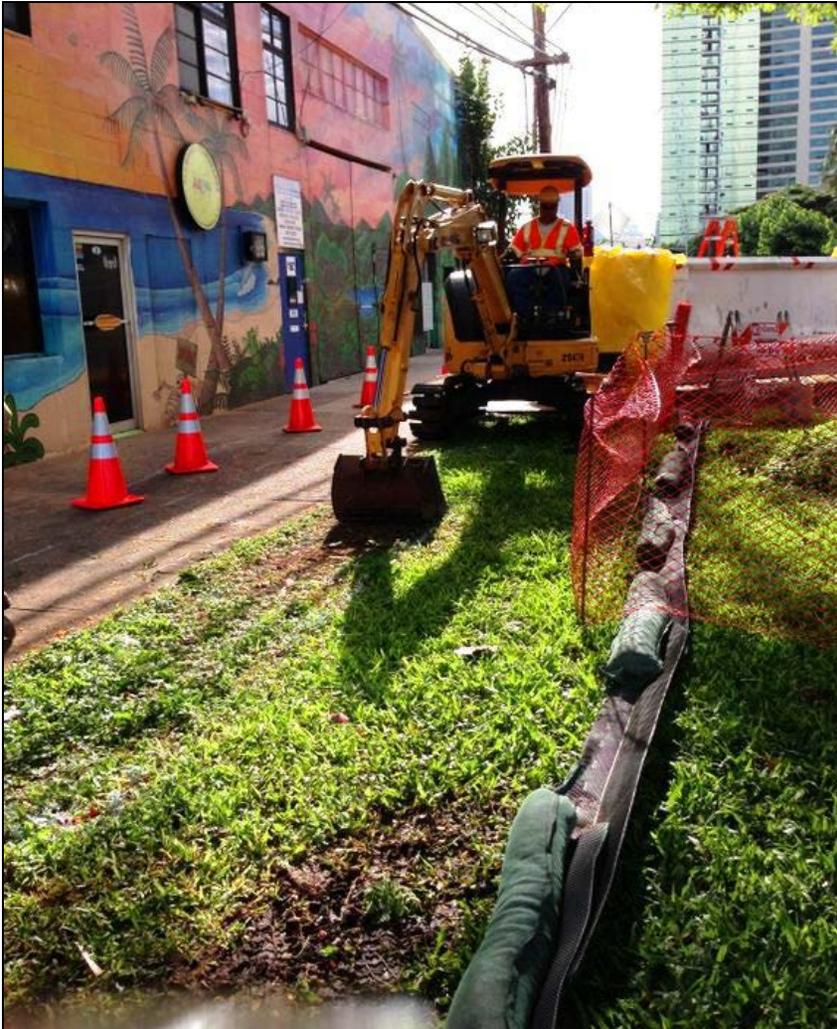
T-184 general location, view to east

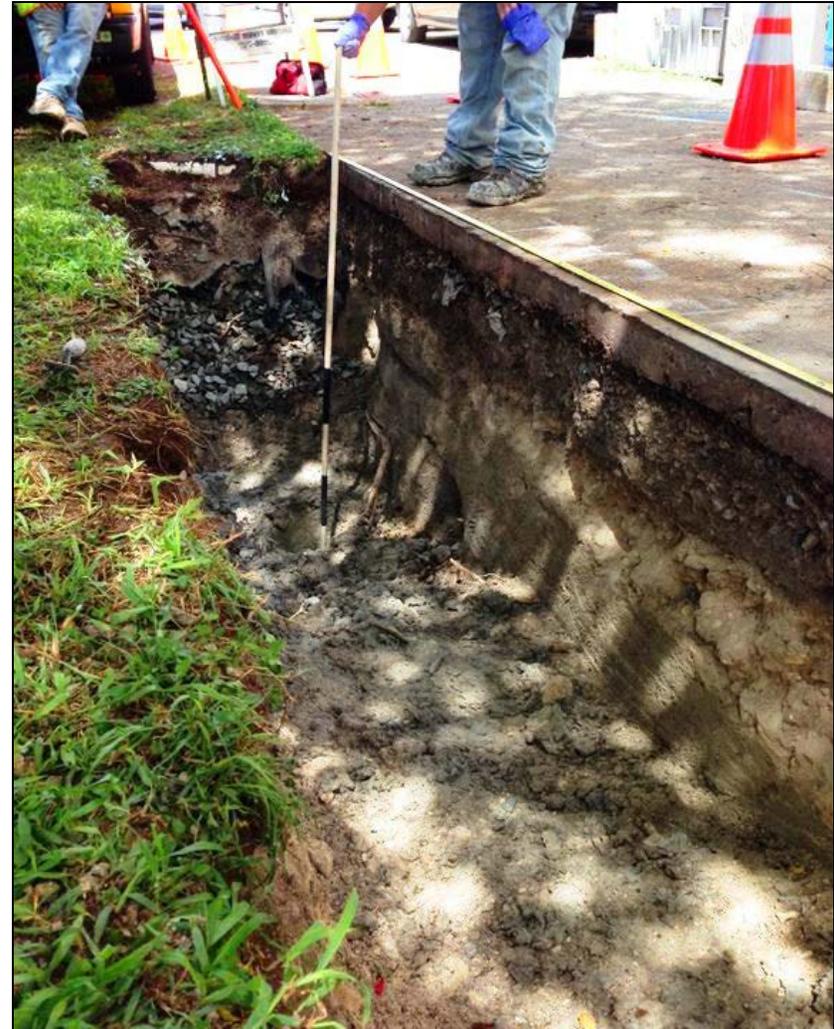
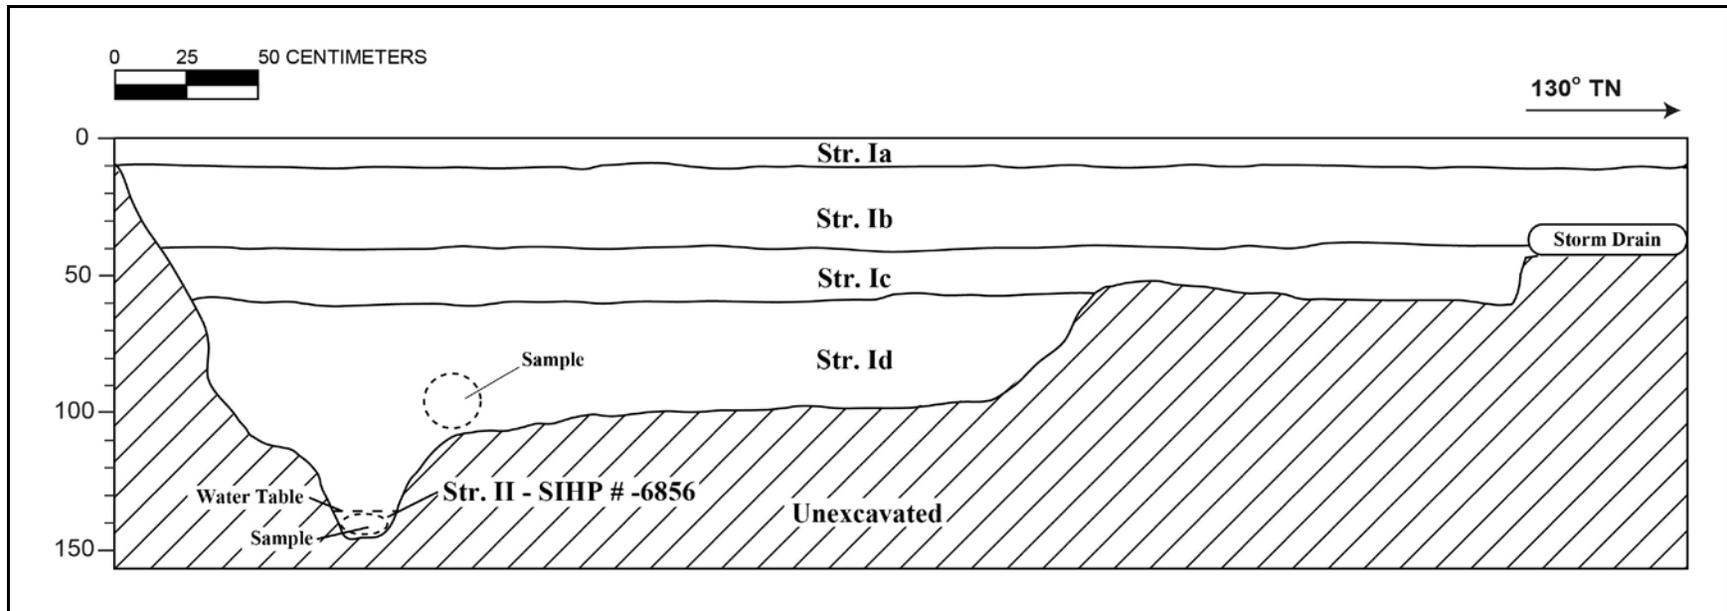
Summary: T-184 was excavated to a depth of 1.47 mbs and beneath the water table at 1.40 mbs. T-184 was located within the previously established boundary of Kolowalu Fishpond (SIHP #50-80-14-6856). Stratigraphy of T-184 consisted of fill (Ia to Id) overlying natural sediment (II) to beneath the water table. The stratigraphy generally conformed to the USDA soil survey designation of Fill land. A total of two bulk samples were collected from T-184, including one from Stratum Id at 0.86–1.06 mbs (3.8 L) and one from Stratum II at 1.39–1.46 mbs (3.8 L). The bulk samples were wet-screened. Contents from Stratum Id included marine shell content that

was considered to be a naturally-occurring within the sediment matrix. Sample analysis of the material collected from Stratum II appeared to document the natural deposition of marine shell within a backshore wetland environment during storm or tidal events. The organic content that was observed within Stratum II (*Ruppia maritima* seeds and charcoal or carbonized plant matter) was considered to be naturally-deposited organic content consistent with wetland sediment. The natural sediment (II) within T-184 was considered to be a possible remnant of Kolowalu Fishpond (SIHP #50-80-14-6856).

T-184 northeast profile wall, view to north

T-184 northeast wall profile

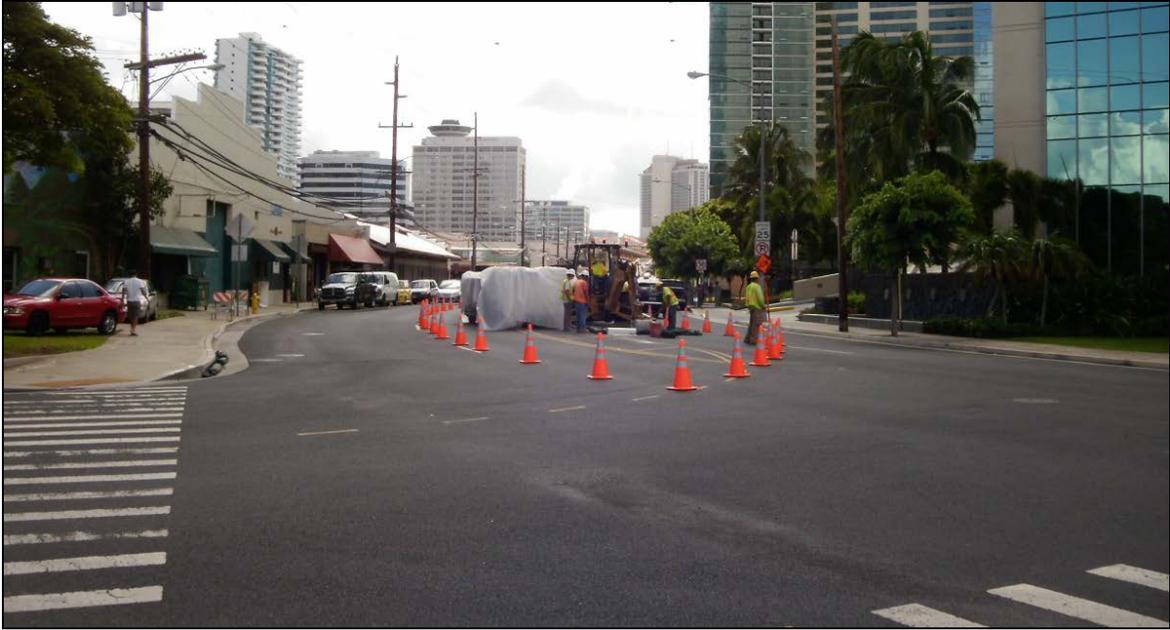
T-185 general location, view to east
