Section 2 Zone 9 East Kaka'ako (Test Excavations 179 to 197)

For reporting purposes for this AIS, the City Center Section 4 of the Honolulu High-Capacity Transit Corridor Project (HHCTCP) has been divided into 11 zones based on geographical and cultural boundaries. The East Kaka'ako Geographic Zone extends from Kamake'e and Queen Streets at the west end, through Waimanu and Pensacola Streets, and follows Kona Street to Pi'ikoi Street, which marks the east end (Figure 2). The central portion of this zone lies within the historic Kolowalu Fishpond (see Volume II). The East Kaka'ako Zone corridor is located entirely within Honolulu Ahupua'a. Pi'ikoi Street marks the *ahupua'a* boundary between Honolulu and Waikiki Ahupua'a.

The East Kaka'ako Zone includes 19 AIS Test Excavations numbered T-179 through T-197 (T-197 was abandoned because it was located in an existing building; however, T-196 was placed in the immediate vicinity of T-197, between the straddle-bent columns and within the utility relocation corridor, and pertinent information was collected from this area). Test excavations were generally numbered from west to east. The Test Excavations within the East Kaka'ako Zone were

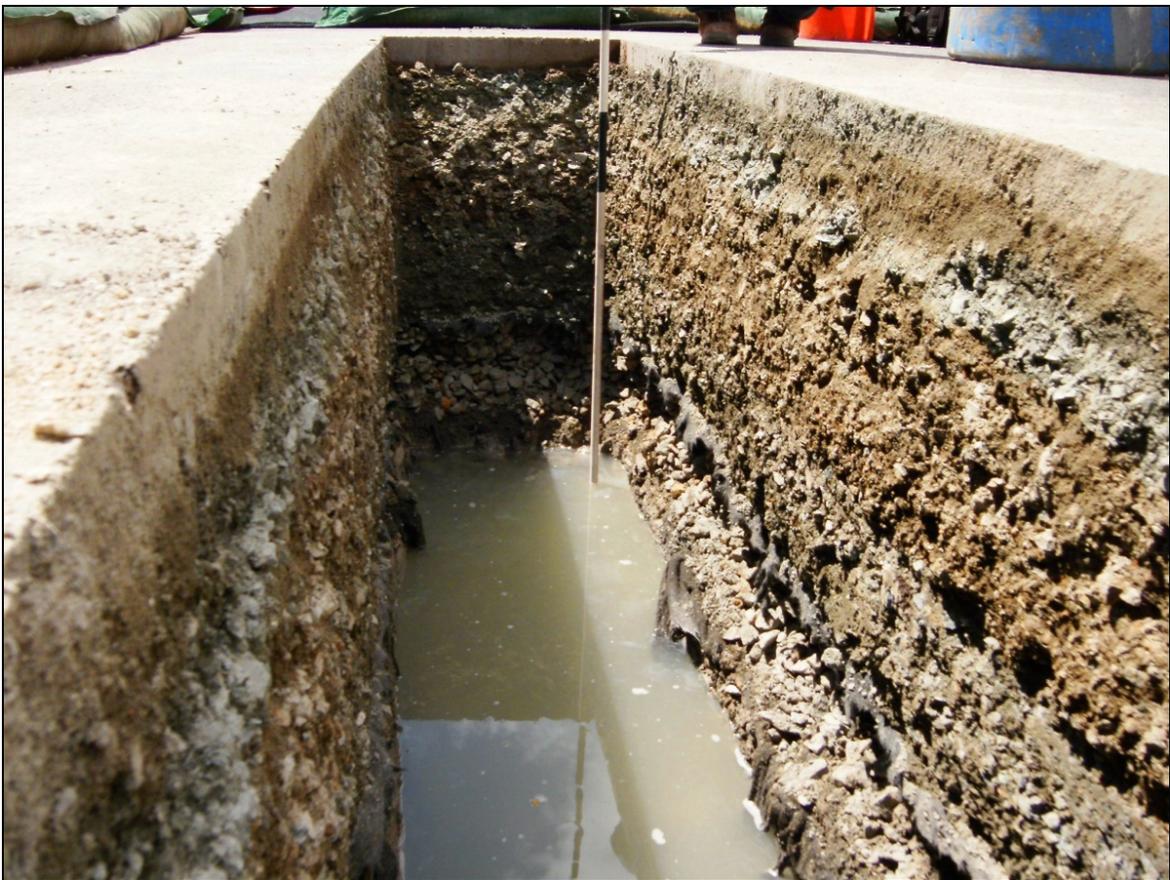
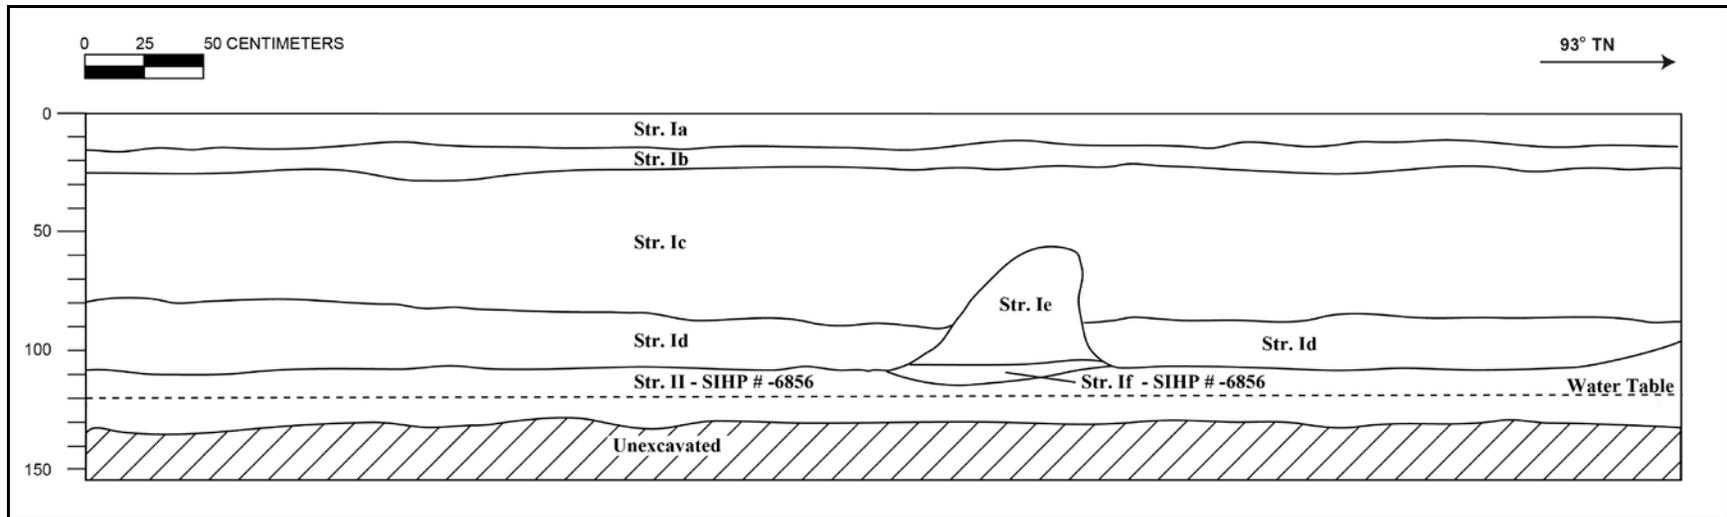
Summary: T-185 was excavated to a depth of 1.35 mbs and beneath the water table at 1.20 mbs. The stratigraphy at T-185 consisted of fill (Ia to If) overlying natural sediment (II) to the base of excavation. The stratigraphy generally conformed to the USDA soil survey designation of Fill land. T-185 was located within the previously established boundary of Kolowalu Fishpond (SIHP #50-80-14-6856). Stratum If may represent a berm associated with Kolowalu Fishpond. The natural sediment (II) within T-185 was considered to be a possible remnant of Kolowalu Fishpond (SIHP #50-80-14-6856).

T-185 north profile wall, view to west

T-185 north wall profile

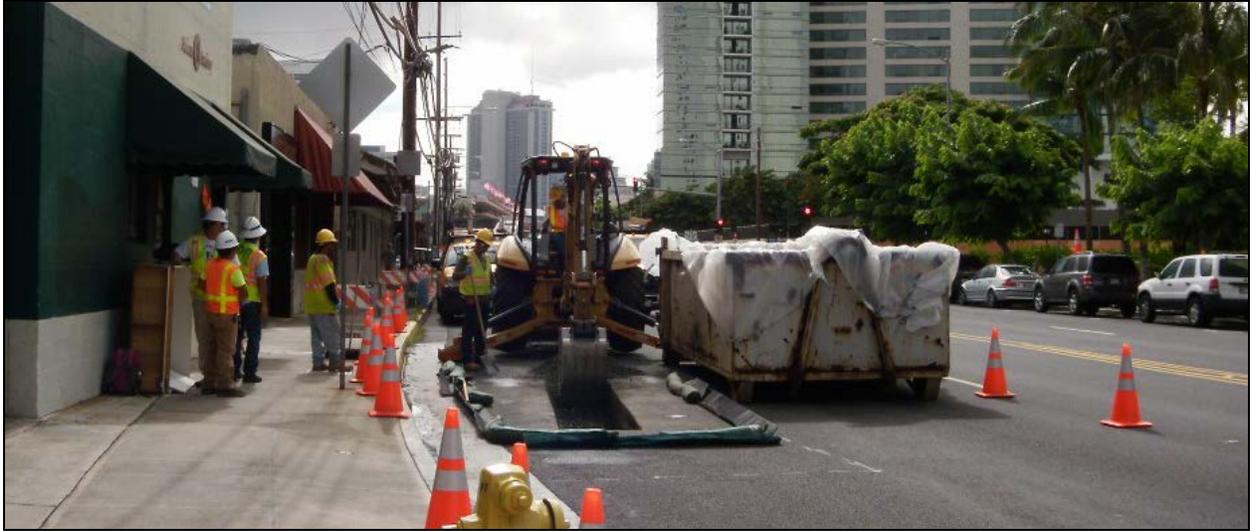
T-186 general location, view to southeast

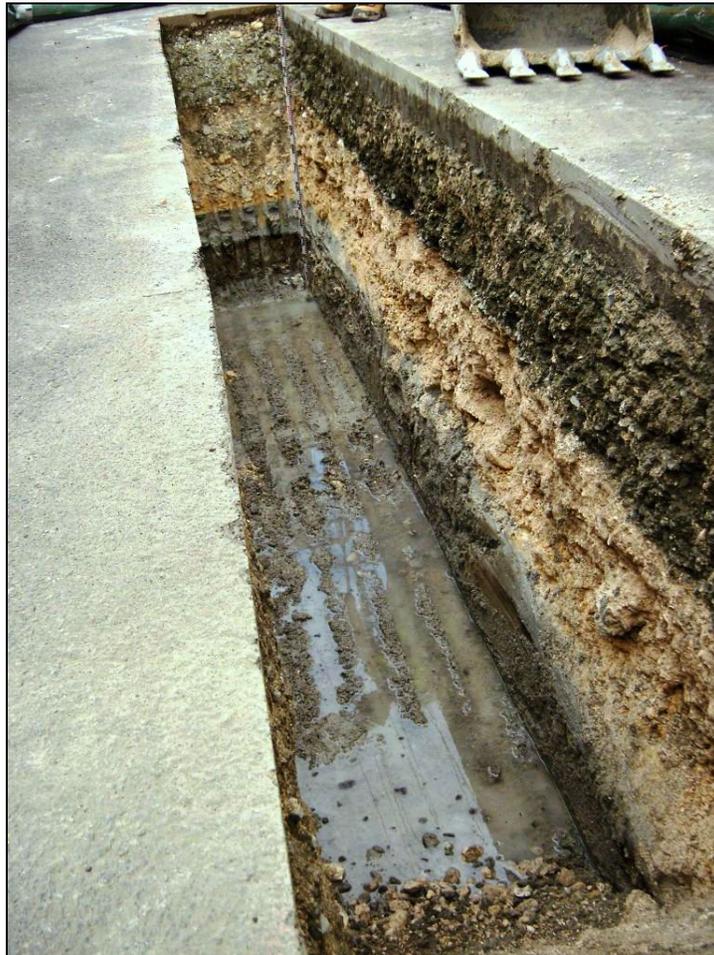
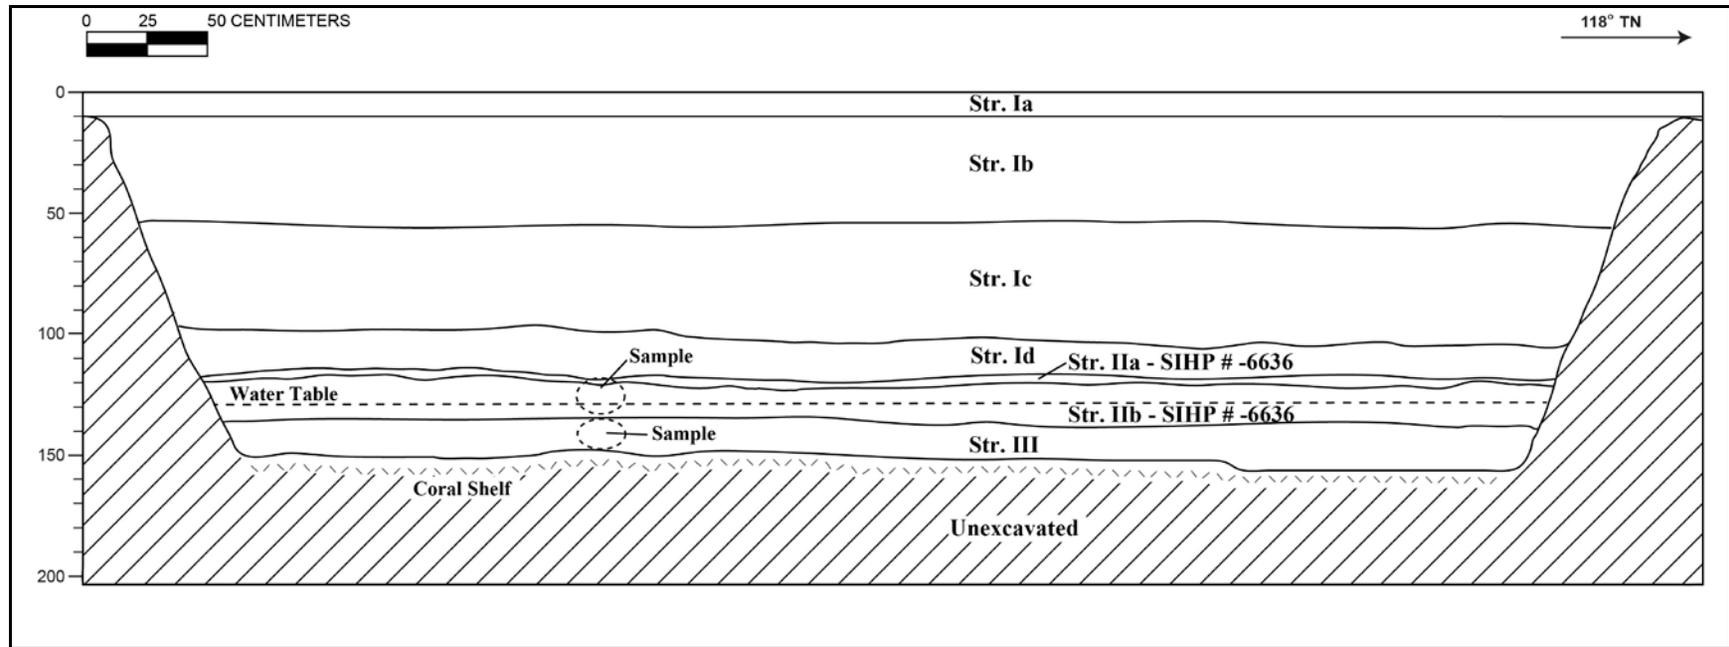
Summary: T-186 was excavated to a depth of 1.55 mbs and beneath the water table at 1.29 mbs. The stratigraphy of T-186 consisted of fill (IA to Id) overlaying natural sediment (IIa, IIb, and III). The observed stratigraphy generally conformed to the USDA soil survey designation of Fill land. A total of two bulk sediment samples were collected from T-186 including one sample from the Stratum IIa/IIb interface at 1.24–1.37 mbs (2.5 L) and one from Stratum III at 1.35–1.45 mbs (3 L). The results of sample analysis have indicated that the natural sediment within T-186 represented coastal deposits associated with a fresh- or brackish-water environment. The naturally-occurring marine shell within both samples was likely deposited within the environment during storm or tidal events. The natural sediment (IIa and IIb) within T-186 was considered to be a possible remnant of Kewalo wetland (SIHP #50-80-14-6636).

T-186 northeast profile wall, view to northwest

T-186 northeast wall profile

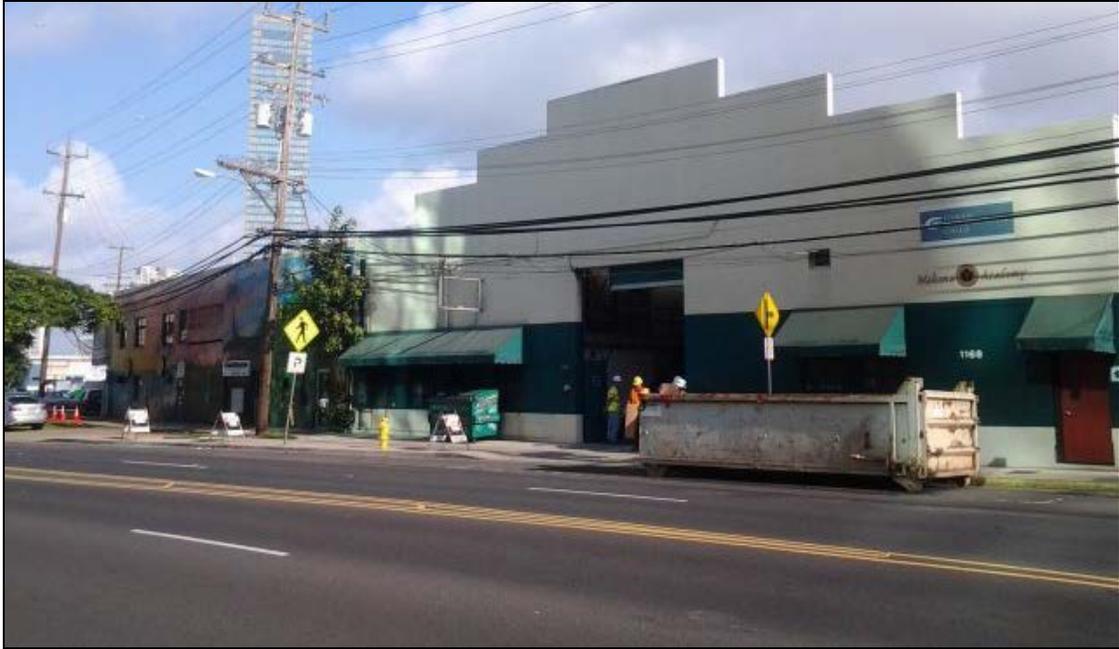
T-187 general location, view to north

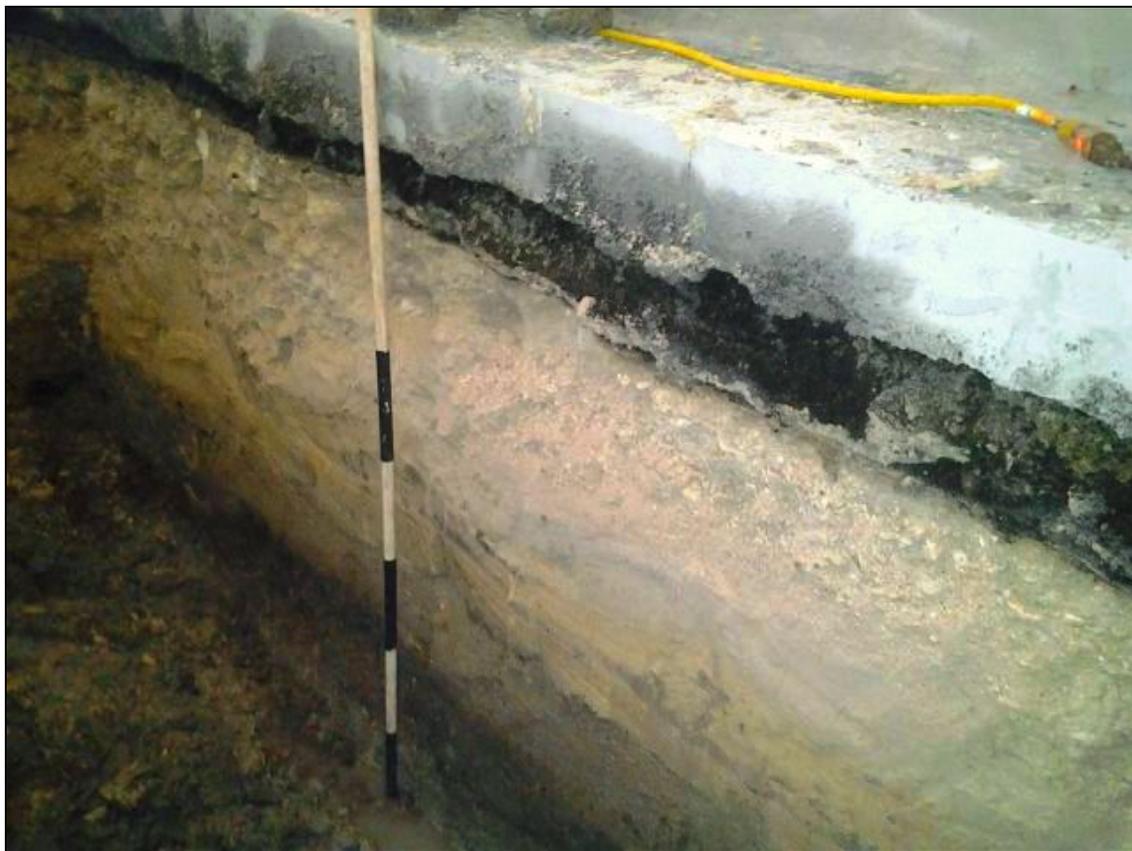
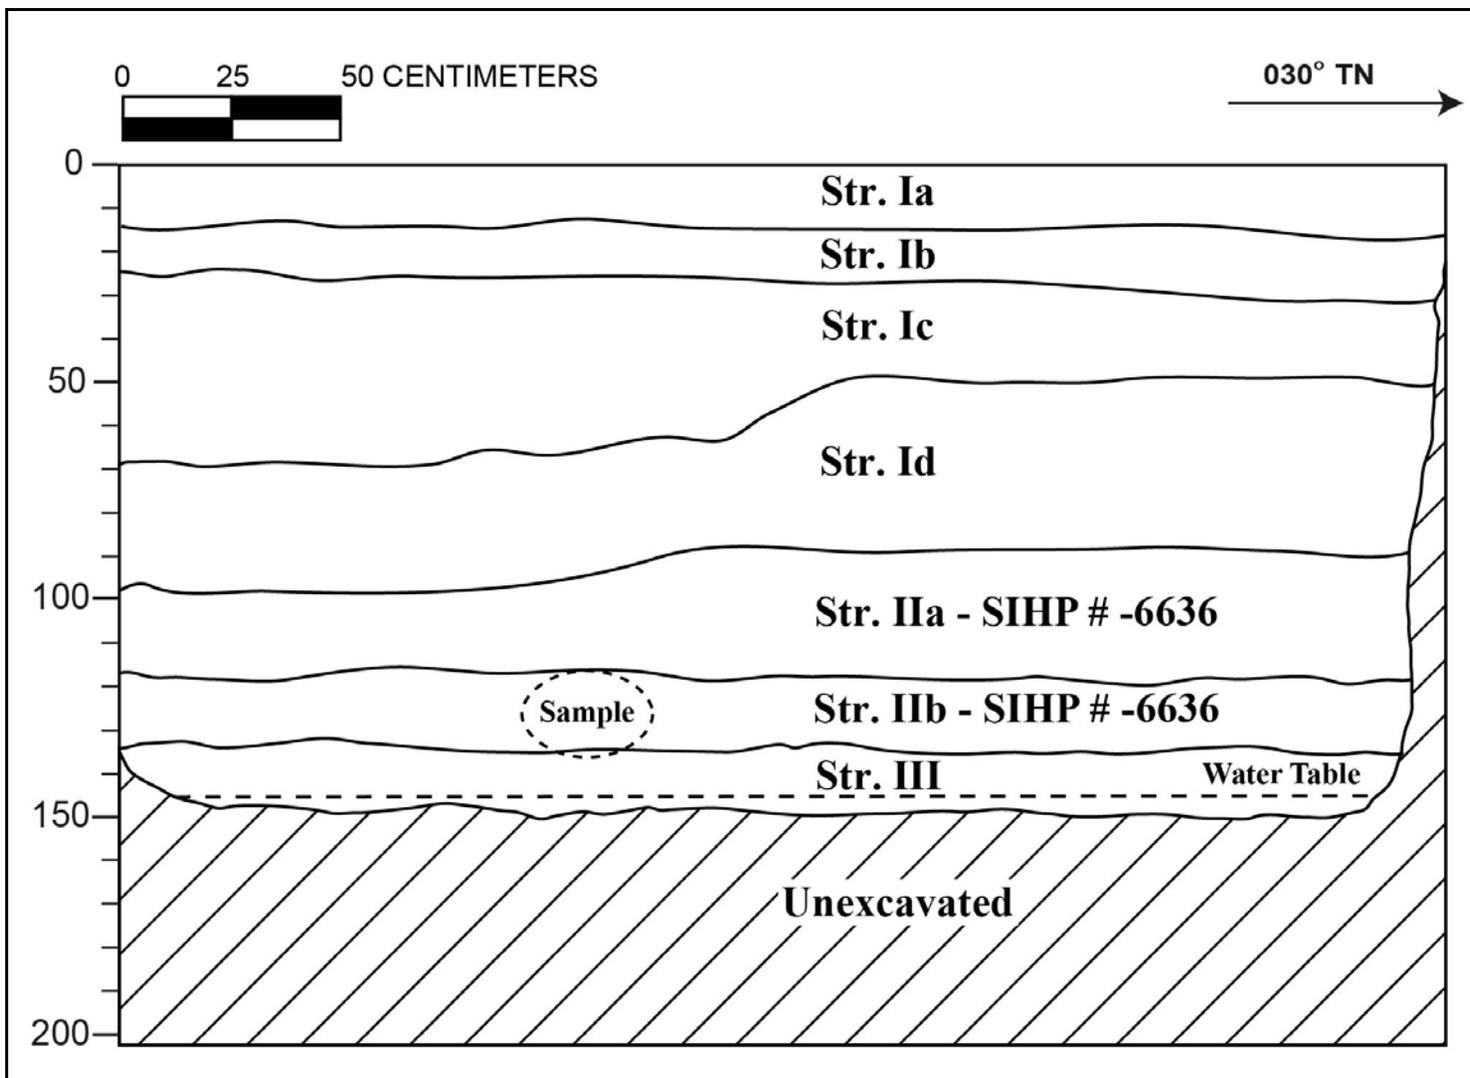
Summary: T-187 was excavated to the water table at a depth of 1.50 mbs. The stratigraphy of T-187 consisted of fill (Ia to Id) overlying natural sediment (IIa, IIb, and III). The stratigraphy generally conformed to the USDA soil survey designation of Fill land (FL). Stratum IIa was considered to be previously disturbed during fill deposition related to land reclamation or urbanization. One bulk sample was collected from Stratum IIb between 1.18–1.36 mbs. The results of sample analysis documented the mixed depositional origin of Stratum IIb, which included natural marine-, natural terrestrial-, and potential culturally-deposited material. The natural sediment (IIa and IIb) within T-187 was considered to be a possible remnant of Kewalo wetland (SIHP #50-80-14-6636).

T-187 northwest profile wall, view to west

T-187 northwest wall profile
