WOFH and KHG Guideway Tendon Issues

Tendon Issue Summary

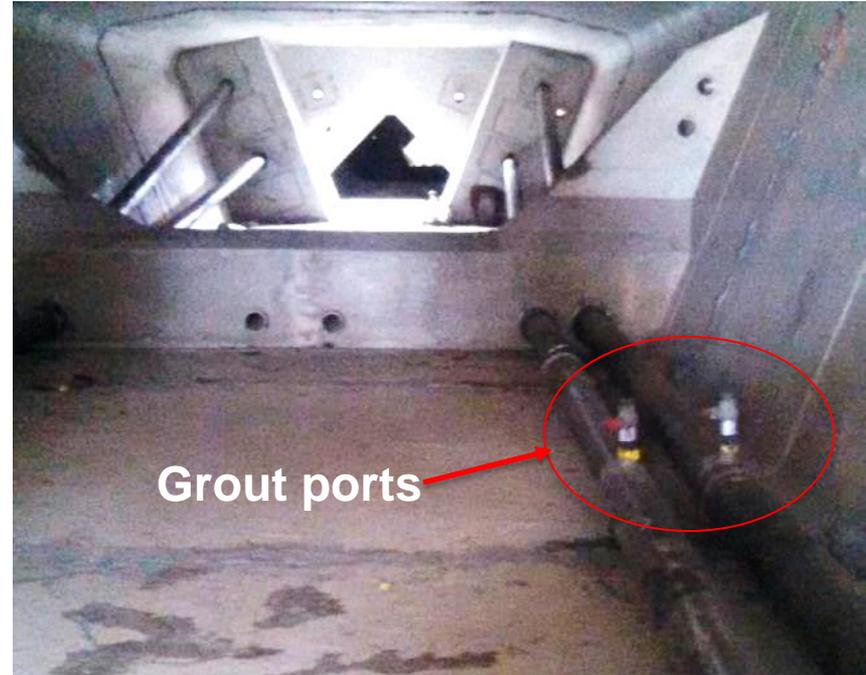
- Tendon protection
 - After tendons are installed, tendons are grouted within 14 days.
 - If not grouted in 14 days, a corrosion inhibiting powder is put in ducts.

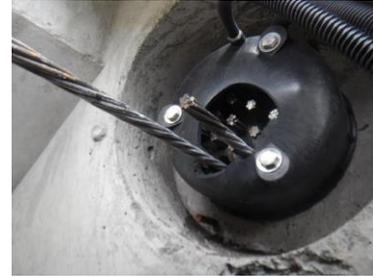
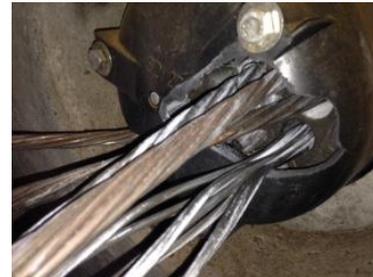
- Span 258:

- **1/25/16:** One tendon with fractured strands
- **4/15/16:** Tendon was replaced and grouted

- Span 249:

- **4/1/16:** Two tendons with fractured strands
- **6/14/16:** Both tendons were replaced and grouted

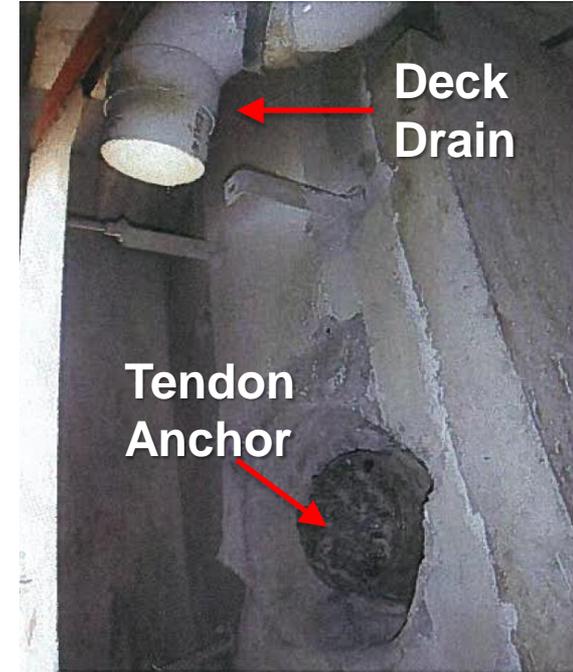
Kiewit's Probable Cause

- Water entered through anchors
- Corrosion inhibitor not effective with water in the duct
- Corrosion & fractures limited to anchor area
- Corrosion leads to fractures

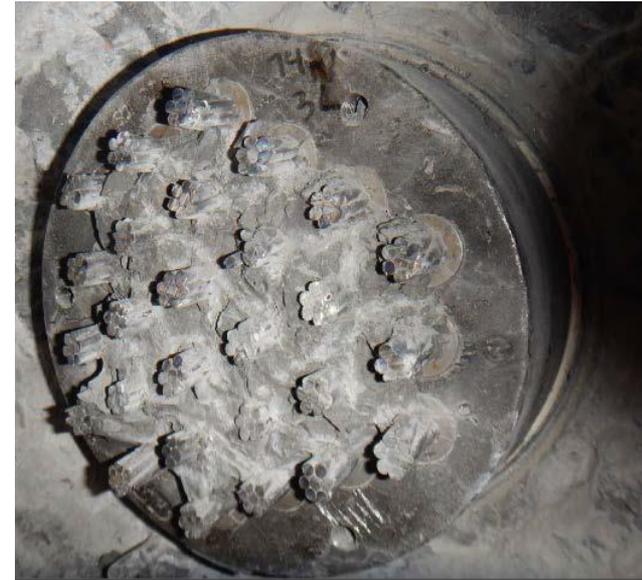
- Kiewit chipped out grout to expose anchors
 - **Stage 1:** 26 tendons with water in ducts or exceeding 180 days between stressing and grouting.
 - 2 corroded anchors discovered and replaced.

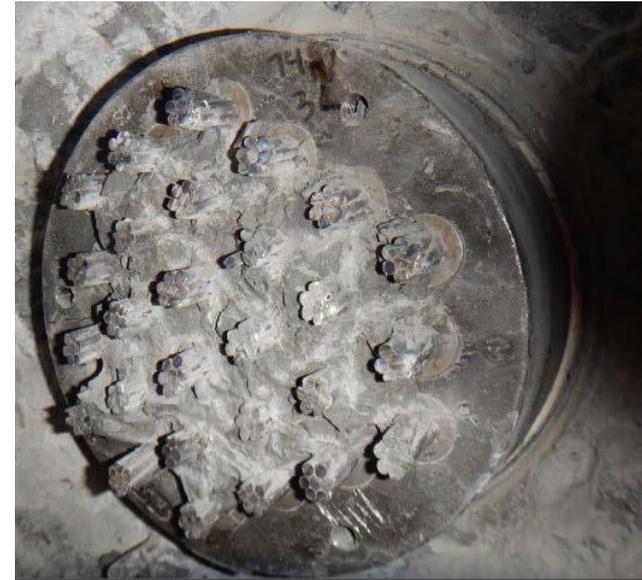
- Kiewit chipped out grout to expose anchors
 - **Stage 2:** 6 tendons that had problems with grout quality caused by water in the ducts.
 - 1 corroded anchor discovered and replaced.

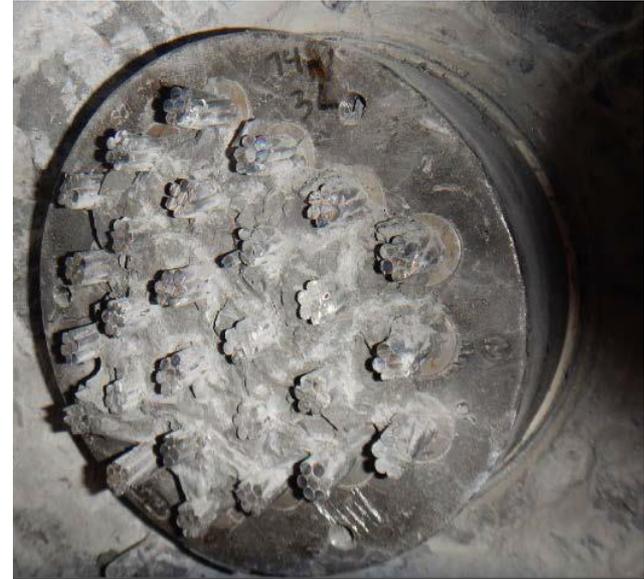
- Kiewit chipped out grout to expose anchors
 - **Stage 3**: A random sampling of 25 tendons based on statistical analysis.
 - HART evaluating sample size
 - No corroded anchors discovered

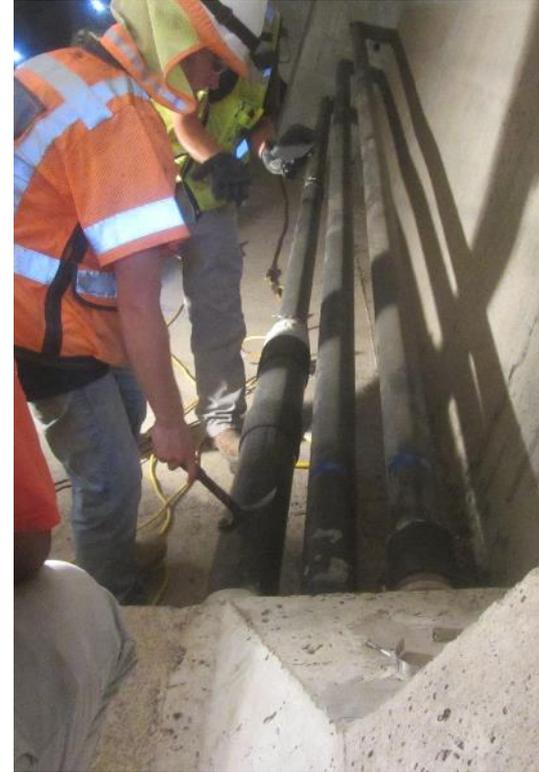
- Kiewit's grout records showed
 - 18 Tendons had grout voids (vacuum grouted per spec)
 - 6 Tendons had soft grout (replaced)
- Kiewit inspected all tendons by sounding with hammers
- Proper grouting halts corrosion
