**DILLINGHAM BOULEVARD RESIDENCES, GENET HOUSE
(Afuso House)
1953 Dillingham Boulevard
Honolulu
Honolulu County
Hawaii**

HABS No. HI-558-A

**Historic American Buildings Survey
National Park Service
Department of the Interior
San Francisco, California**

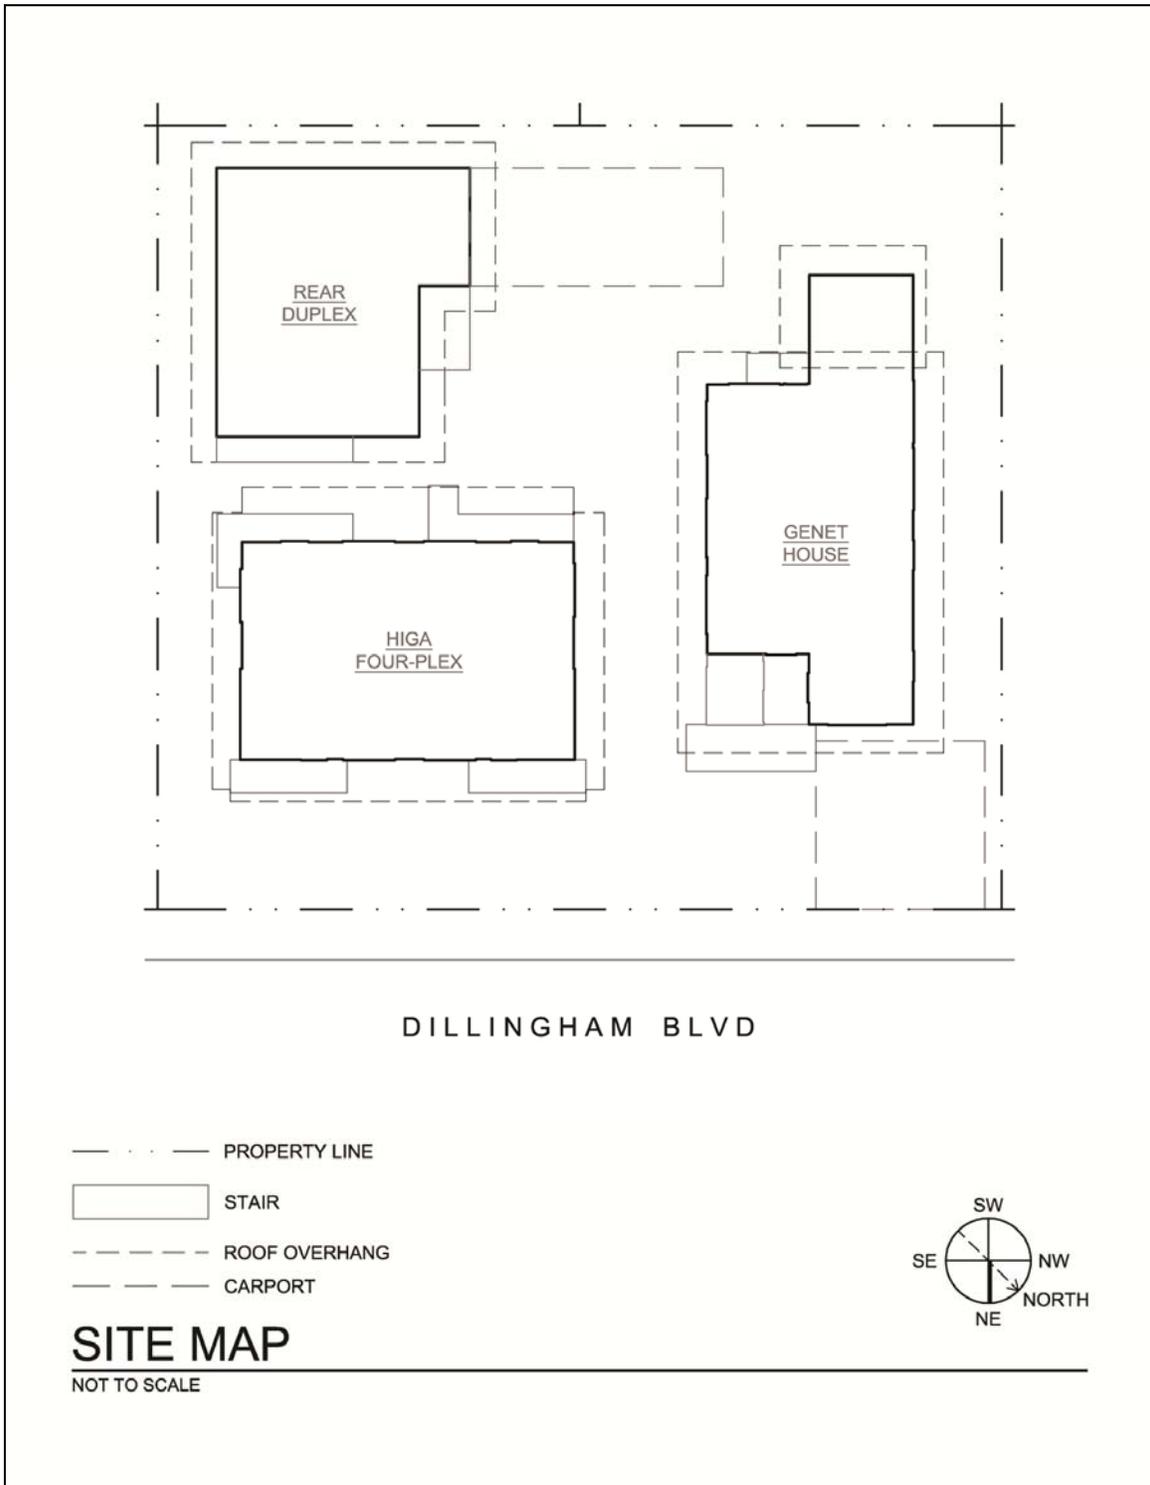
Site Plan *Mason Architects, Inc., August 2013*

- b) The house sits on a lot that is approximately 9,300 square feet, along with two other residences. The Genet House is on the northwest half of the lot.

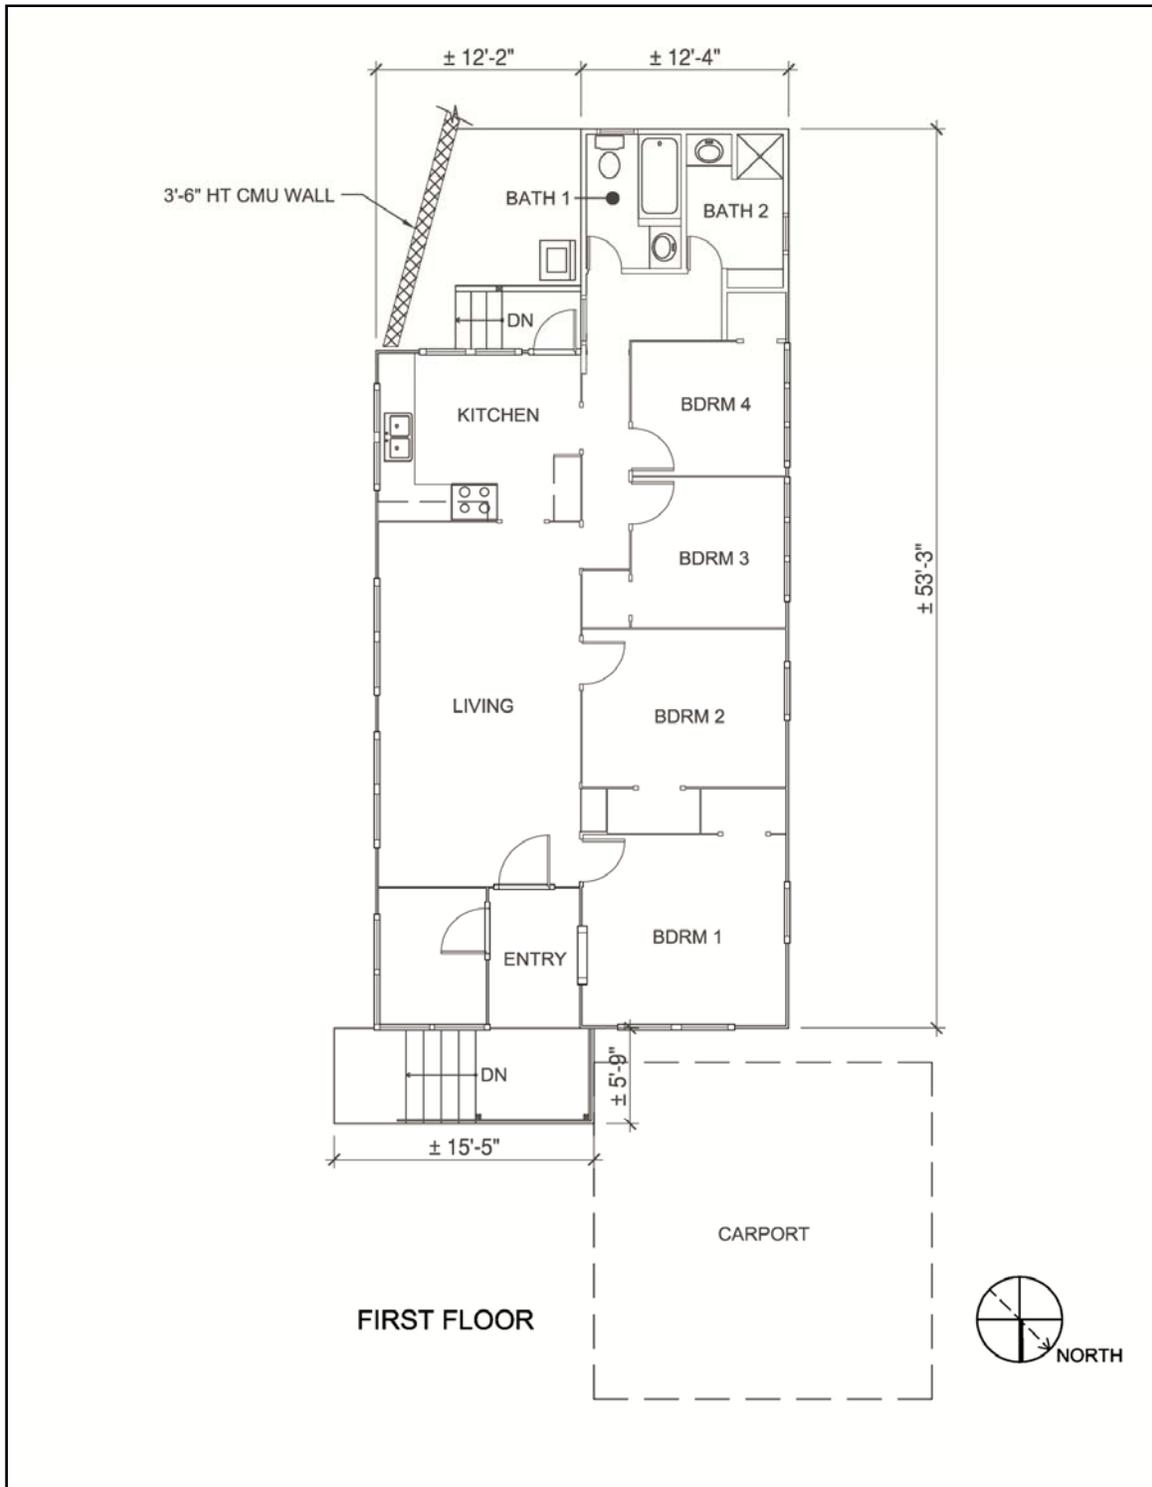
Floor Plan Mason Architects, Inc., August 2013

1. **Floor plan:** The one-and-one-half-story Genet House has a living room, kitchen, central hallway, two bathrooms, bathroom hallway and four bedrooms, as well as a storage room (former porch) which is only accessible from the front entryway. Prior to the rear bathroom addition, the house's original interior layout was a narrow H shape, organized around the central hallway, with the entry porch and a portion of the front bedroom creating the short bottom legs of the H on either side of the entryway. Aligned along the left (southeast) side of

the house are the living room and kitchen, while the bedrooms are along the right (northwest) side. The front two bedrooms are accessible through the living room, while the two rear bedrooms are accessible through the central hall. At the end of the central hall is a perpendicular hallway that gives access to the two bathrooms located in the rear addition.

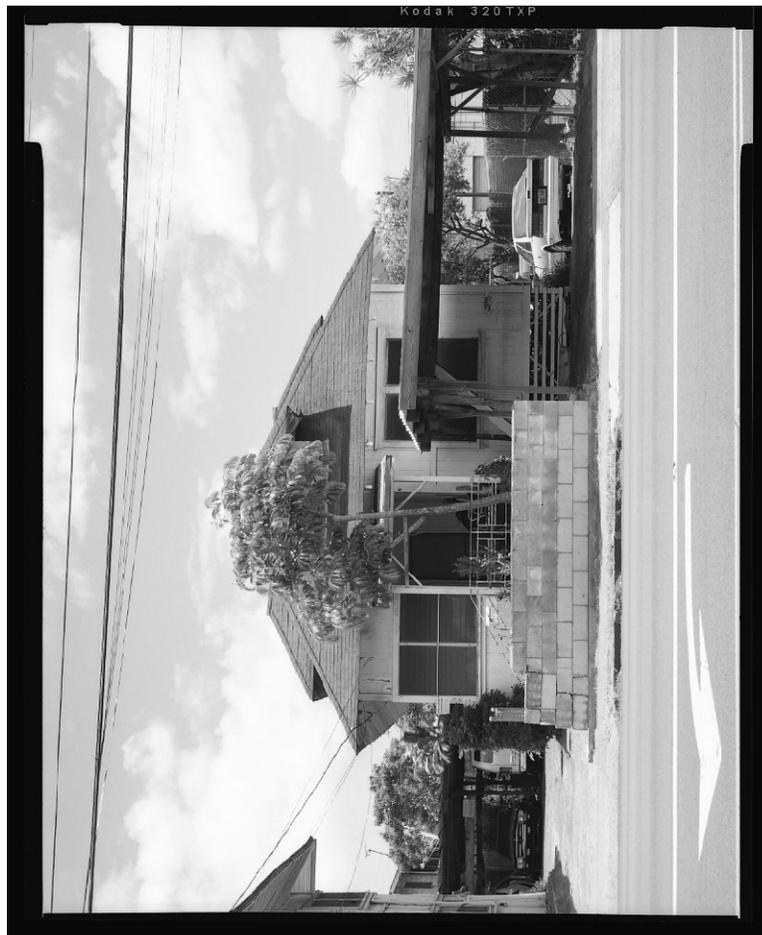
HABS No. HI-558-A-1

- HI-GGG-1 FRONT ELEVATION OF GENET HOUSE FROM OPPOSITE SIDE OF DILLINGHAM BOULEVARD. VIEW FACING SOUTHWEST.
- HI-GGG-2 OBLIQUE VIEW OF FRONT AND SOUTHEAST SIDE OF GENET HOUSE. VIEW FACING WEST.

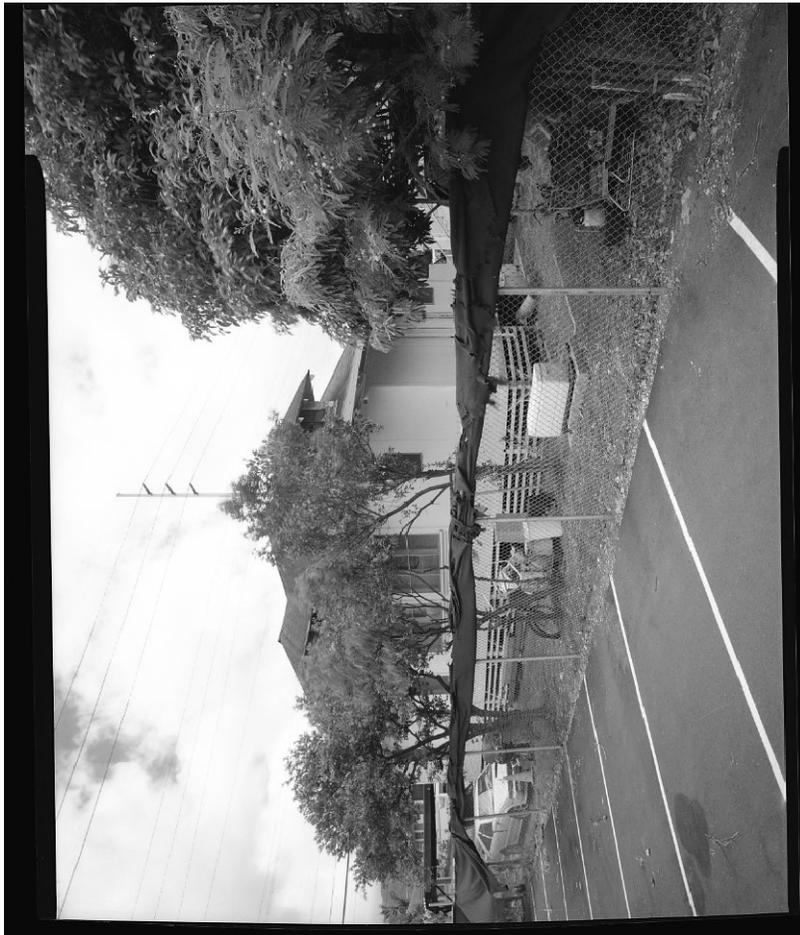
HABS No. HI-558-A-3

- HI-GGG-3 OBLIQUE OF REAR AND NORTHWEST SIDE OF GENET HOUSE. VIEW FACING EAST.
- HI-GGG-4 REAR SIDE OF GENET HOUSE SHOWING POST AND PIER FOUNDATION. VIEW FACING NORTHWEST.

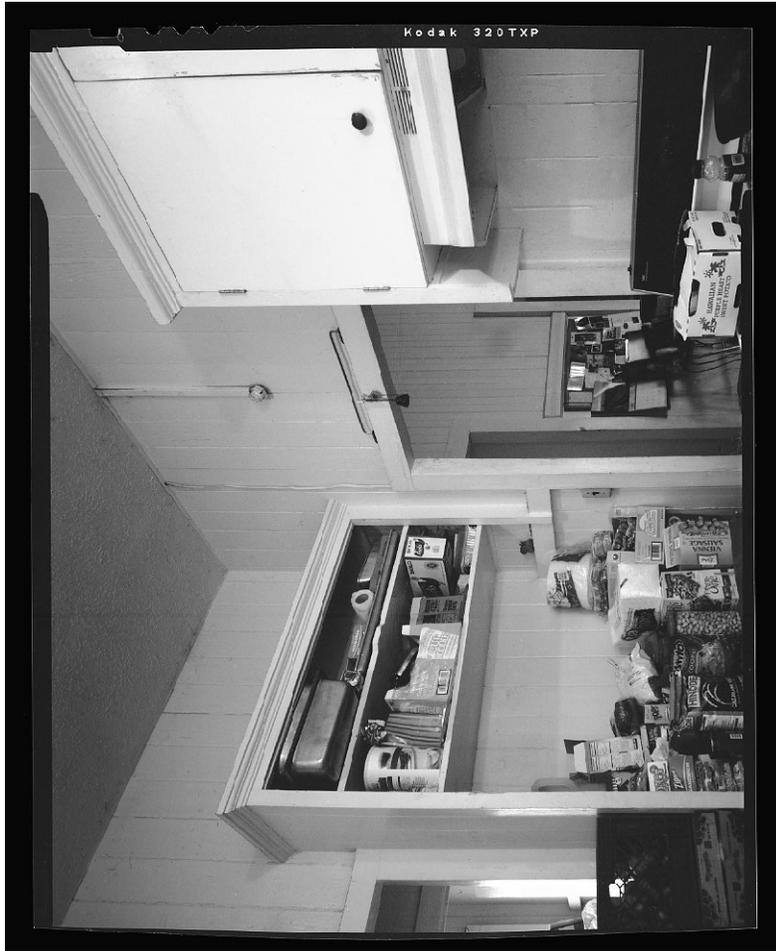
HABS No. HI-558-A-6

- HI-GGG-5 LIVING ROOM FROM ENTRY DOORWAY. VIEW FACING SOUTHWEST.
- HI-GGG-6 KITCHEN SHOWING BUILT-IN PANTRY CABINET. VIEW FACING NORTH.
- HI-GGG-7 BATHROOM 2 SHOWING HISTORIC SHOWER CABIN. VIEW FACING WEST.

- a) Kitchen cabinets and built-ins: The kitchen has period cabinets and hardware, including the pantry cabinet. Decorative crown molding tops both the cabinets and the pantry. The upper and lower cabinets extend along the wall adjacent to the living room, and the lower cabinets wrap around the corner and extend along the southeast wall. The upper cabinets are about 3' high, about 1' deep, and extend about 6' across, with two pairs of doors. The doors closest to the living room entry are only about 30" high, to

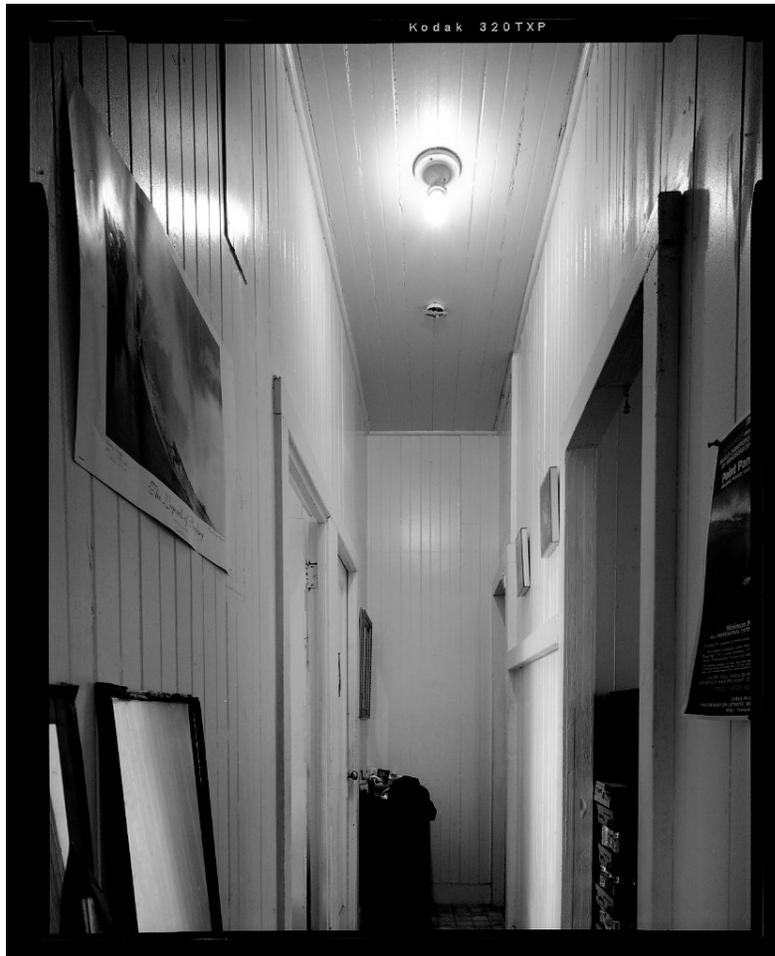
HABS No. HI-558-A-8

- HI-GGG-8 HALLWAY BETWEEN KITCHEN AND BEDROOMS 3 AND 4 SHOWING TONGUE-AND-GROOVE WALLS AND LIGHT FIXTURE. VIEW FACING NORTHEAST.
- HI-GGG-9 BEDROOM 1 SHOWING TALL WINDOW. VIEW FACING WEST.

The hallway walls are vertical tongue-and-groove with a mixture of sizes. Toward the front of the house, on the south side, the walls are center-scored tongue-and-groove matching the living room and kitchen sides of this wall. Toward the rear of the house, on the same side, the walls are wider tongue-and-groove, about 8" wide, matching the other side of this wall in the kitchen.

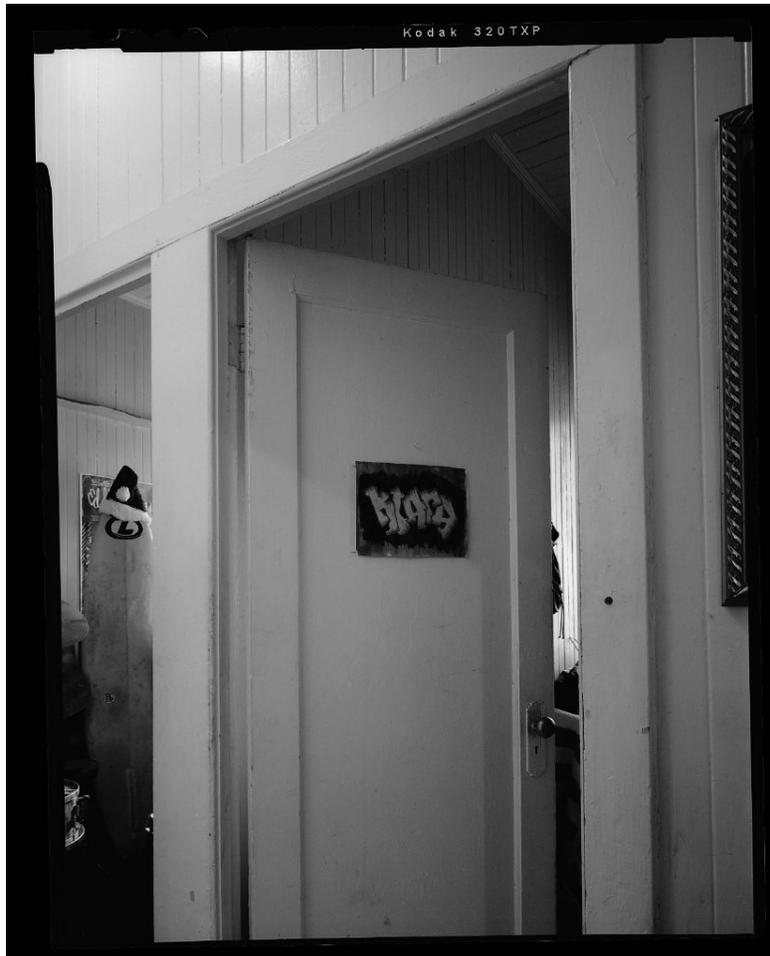
HABS No. HI-558-A-10

- HI-GGG-10 HALLWAY SHOWING HISTORIC DOORS AND HARDWARE. VIEW FACING WEST.
- HI-GGG-11 BEDROOM 1 SHOWING INTERIOR OF BLOCKED EXTERIOR DOOR. VIEW FACING EAST.

- a) Doorways and doors: Most doors in the house are replacements, and all closets are missing their doors. Three doors appear to be historic, the door to bathroom 2, the door to bedroom 3, and the blocked door from the bedroom 1 onto the porch. There are open doorways between the living room and kitchen, living room and center hallway, kitchen and center hallway and center hallway to bathroom hallway. Most doorways have nominal 2x4 framing. Exceptions to this are at the intersection of the two hallways, where there is no framing, and at the living room side of the living room to kitchen doorway, where 2x6 boards are used.
- b) Windows: All accessible original windows at the interior are no longer extant; jalousies are in their place. The original framing has remained in place, however, and is generally made up of undecorated, painted nominal 2x4 lumber.

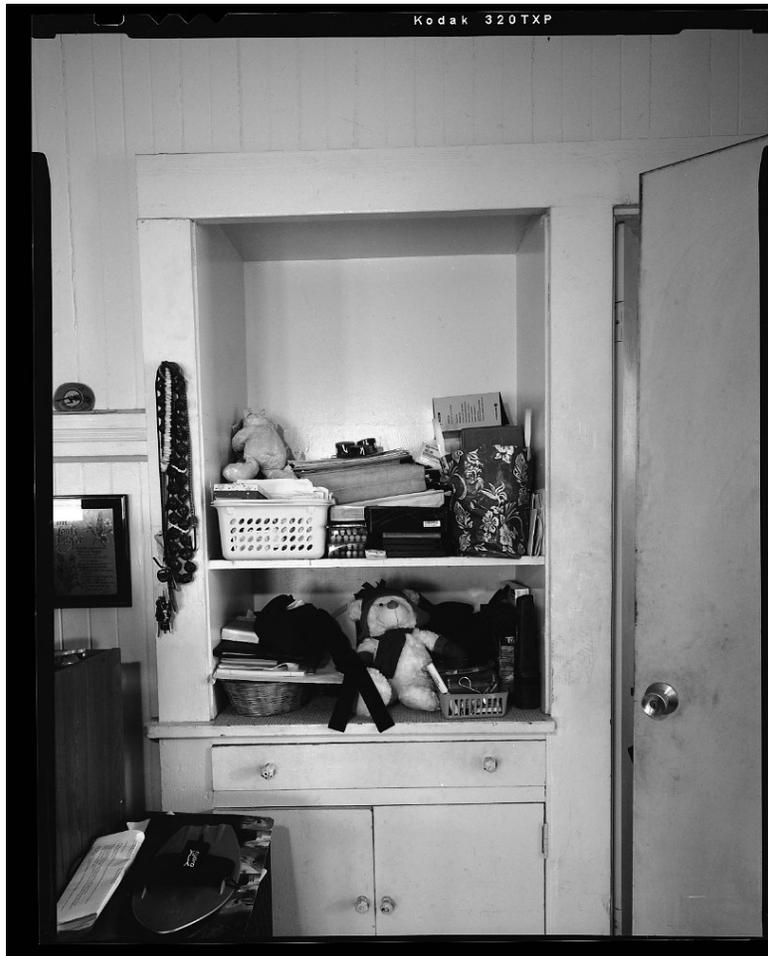
HABS No. HI-558-A-12

- HI-GGG-12 DETAIL OF BUILT-IN CABINET IN LIVING ROOM. VIEW FACING NORTHWEST.

- d) Other interior features: There is a built-in painted wood cabinet in the living room, near the front entry. The unit is approximately 7' high and 18" deep. From top to bottom, the built-in contains two shelves in its top half, a drawer just below the lower shelf, and a cabinet with a pair of flush, painted wooden doors at the bottom. The highest shelf is about 30" from the top of the unit, and the lower shelf is about 1' below the top shelf. The unit has four painted faceted knobs that may be glass or crystal.
